Floor level

**General view of underside**

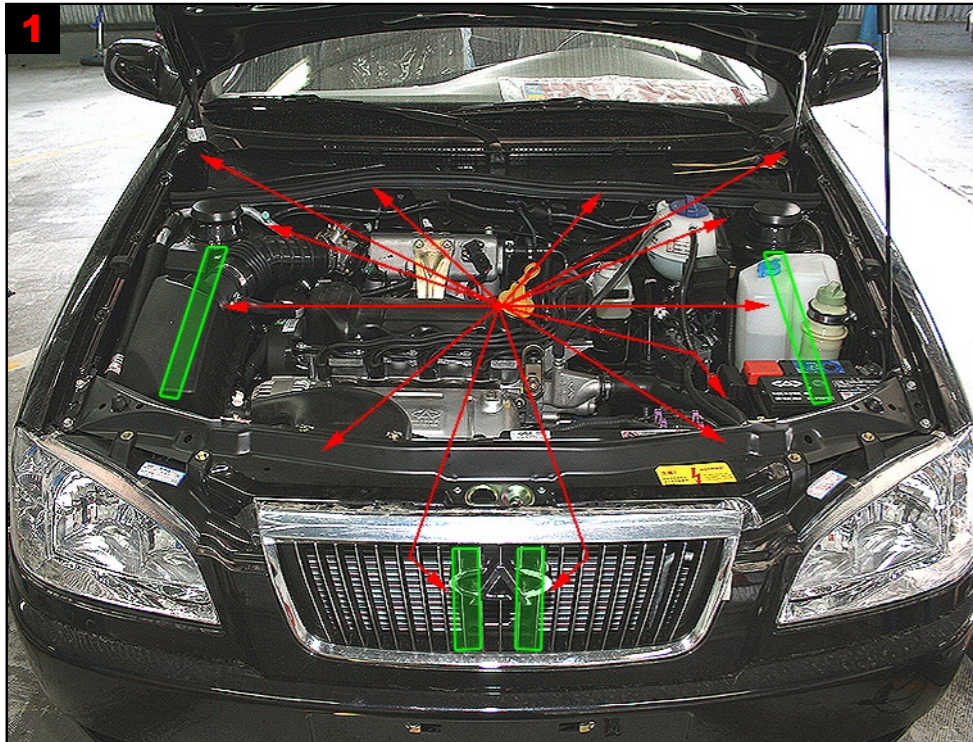
**1**  
Engine compartment:  
Cowl: Remove rubber strip, flip up plastic plate, treat in underneath.  
Treat behind spring struts, along top of longitudinal members, under battery box, around hinges for bonnet lid, cross member above radiator and reinforcement behind radiator grille.

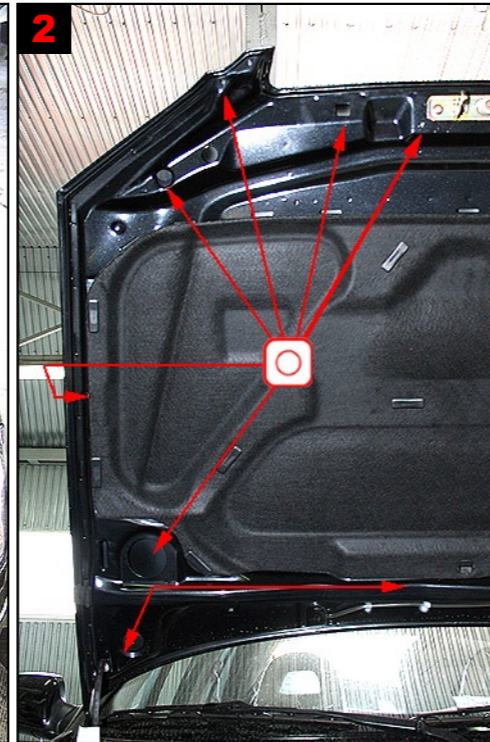
**2**  
Bonnet lid:  
Treat via existing holes.

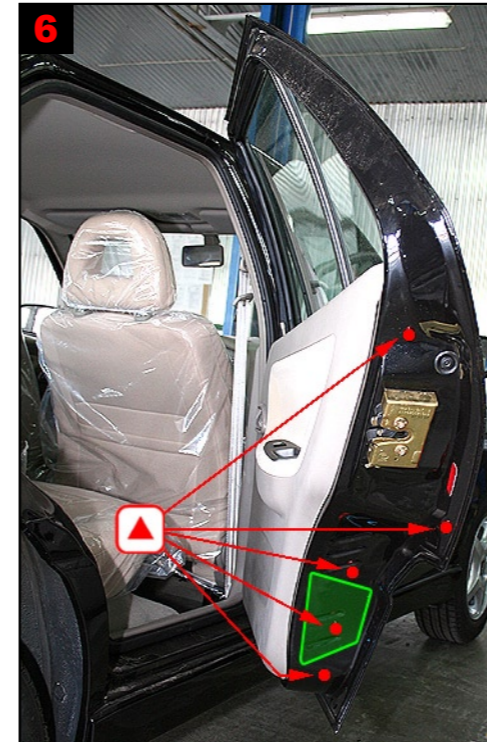
**6**  
Rear door:  
Treat via 5 drilled holes.

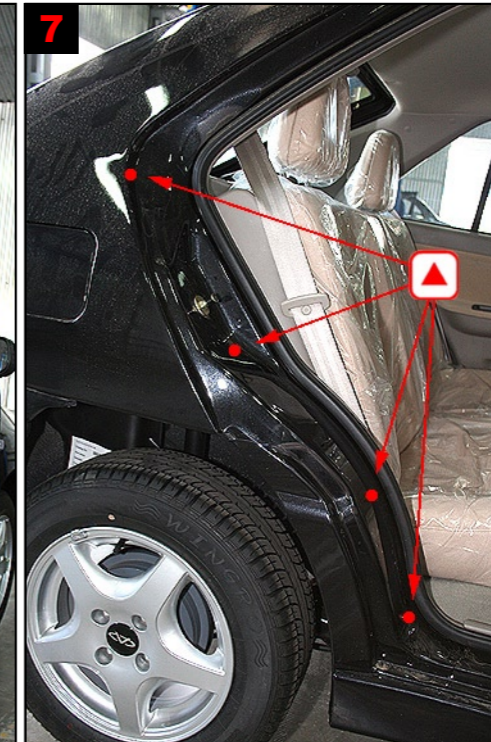
**7**  
C-pillar:  
Treatment via 4 drilled holes.

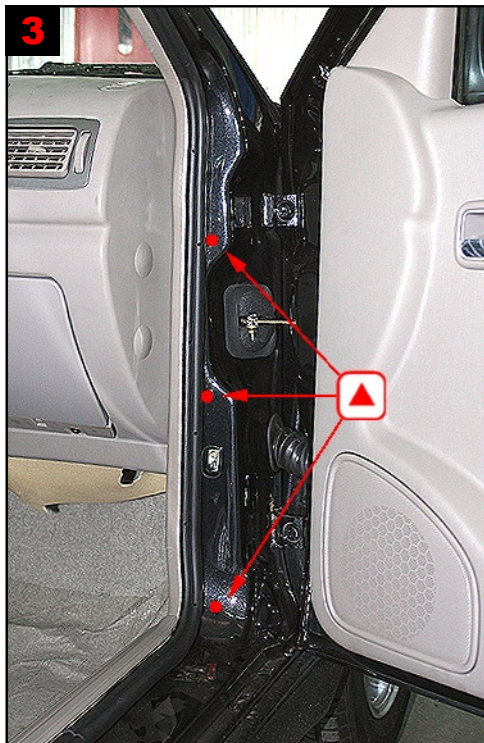
**3**  
A-pillar:  
Treat via 3 drilled holes.

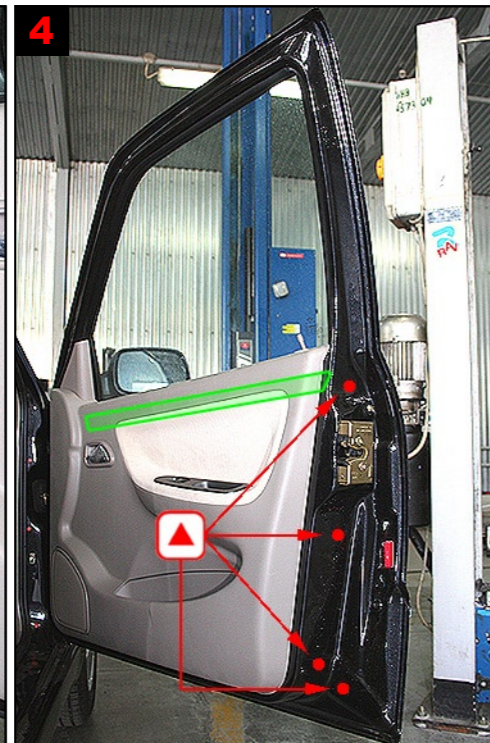
**4**  
Front door:  
Treatment via 4 drilled holes.  
Lower drill hole is drilled with caution.

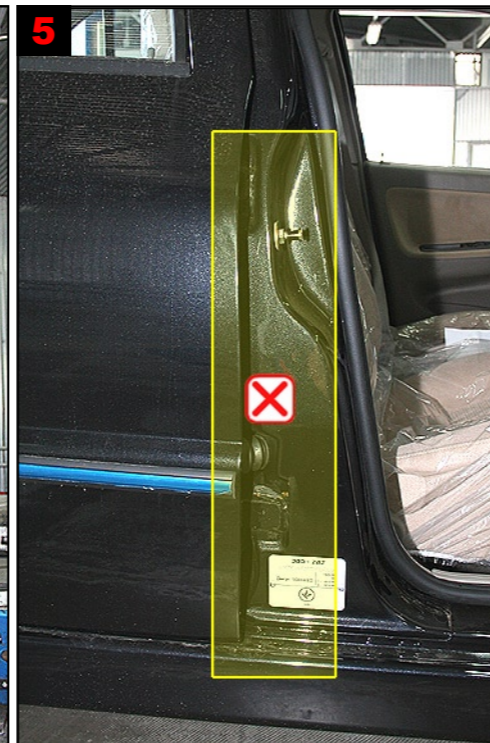
**5**  
B-pillar:  
No treatment because of safety belt and wires.

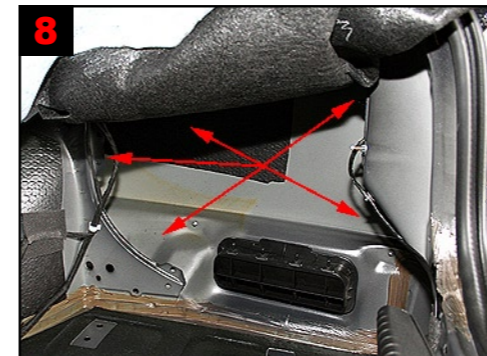
**8**  
Rear wing:  
Treatment from boot.  
Flip up lining - treat in all directions.

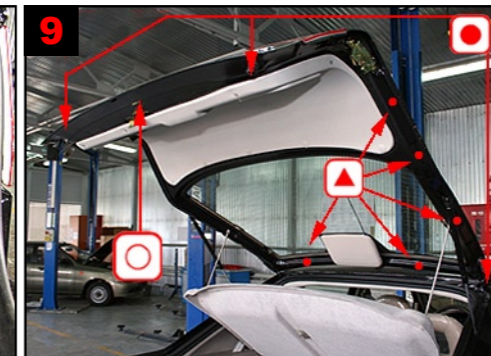
**9**  
Tailgate:  
Treat via existing hole. Drill 5 holes and use 3 existing plugged holes.

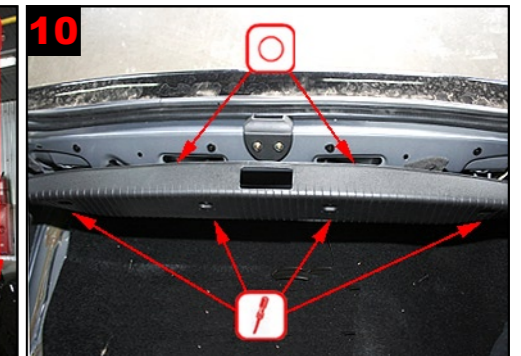
**10**  
Rear panel:  
Remove 4 screws, flip up plastic plate.  
Treat via existing holes.
