Treatment diagram

Floor level

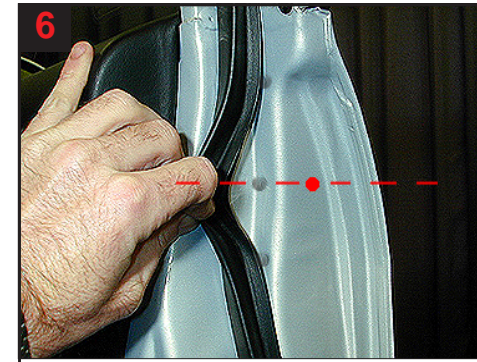
Front door:
Drill level with spot weld no. 2.

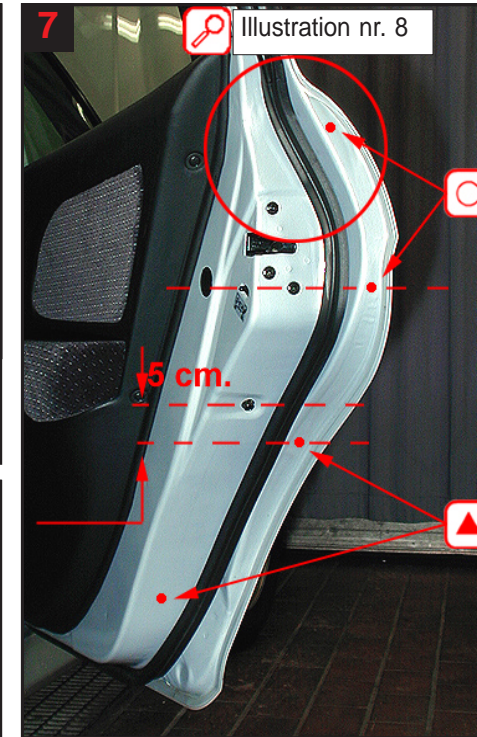
Rear door:
Treatment via 4 drilled holes. See fig 8 for correct top drilling.

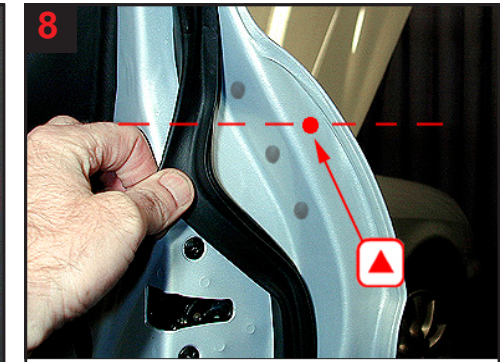
Rear door:
Drill between spot welds 1 and 2.

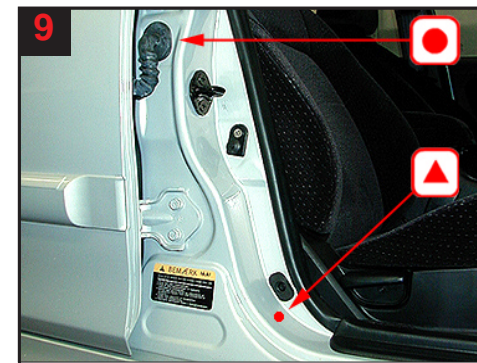
B-pillar:
Treat via grommet (remainder via holes in panel underside).

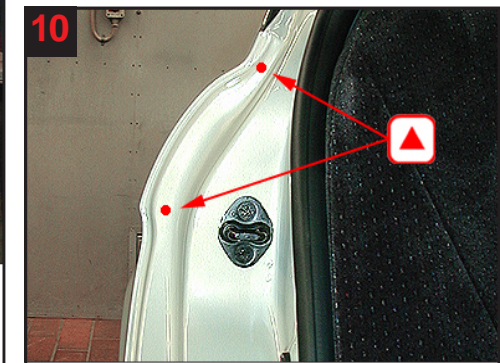
C-pillar:
Fig: correct drilling in top part.

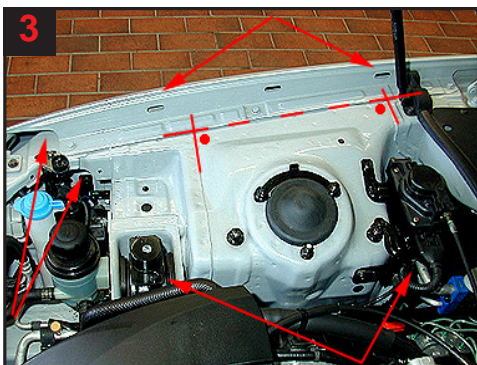
Fig: correct treatment of top member in wing and engine compartment.

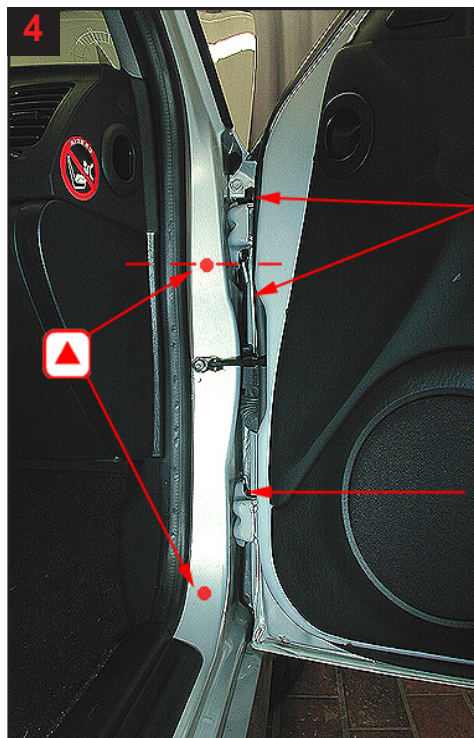
A-pillar/front wing: A-pillar: Treat via 2 drilled holes (top drilling level with underside of door hinge). Front wing: Treat with lance from clearing between A-pillar and wing.

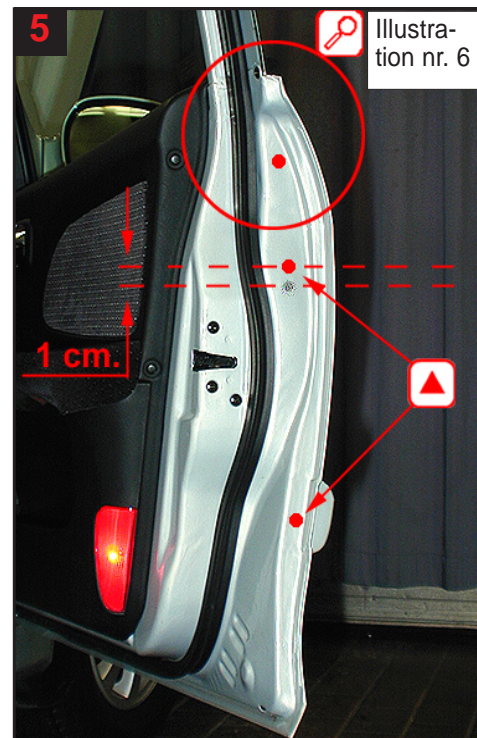
Front door:
Treat via 3 drilled holes. See fig 6 for correct top drilling.

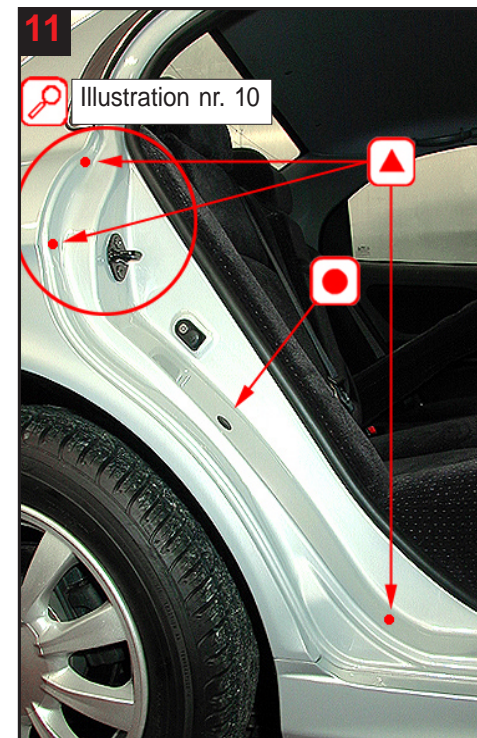
C-pillar/rear wing:
Treat via 3 drilled holes and existing plugged hole. See fig 10 for correct drilling.

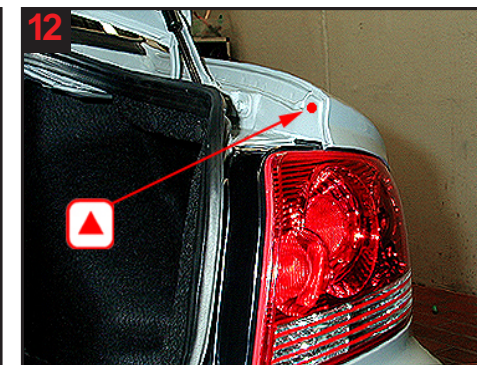
Rear wing:
Treat via 1 drilled hole above tail light.

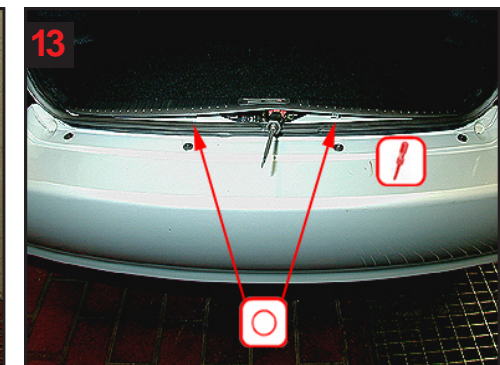
Rear panel:
Flip out cover plate, treat via existing holes for clips.

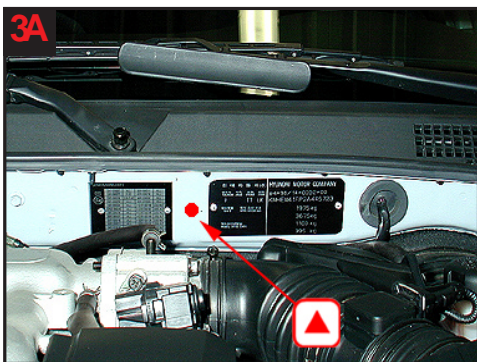
Fig: correct drilling of cowl.

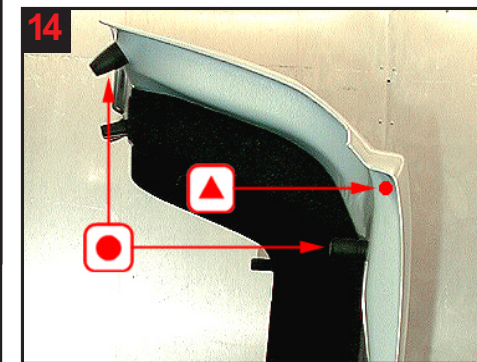
Tailgate:
Treat via 1 drilled hole and existing plugged holes.

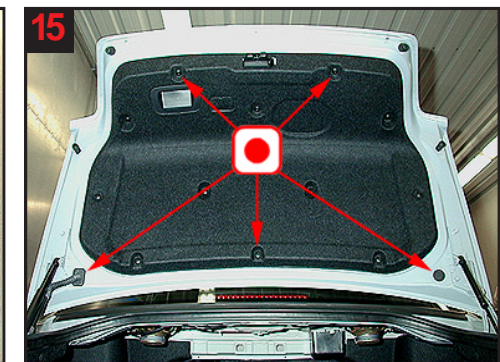
Tailgate:
Treat via existing plugged holes.
