Seat Altea 4D - HB
Model 2004

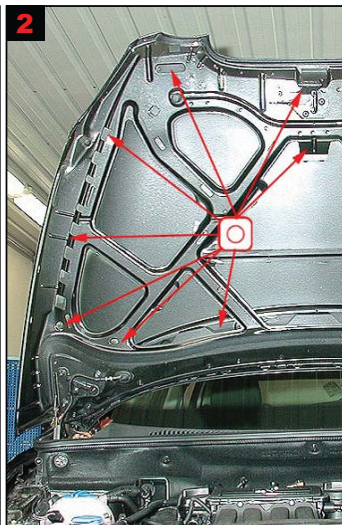
1
Engine compartment:
Cowl: Treat from sides and gaps in grate.
Treatment behind spring struts, on top of longitudinal members, under fluid reservoir, electronic box, fuse box and air filter box. See fig 3 and 4 for correct treatment.

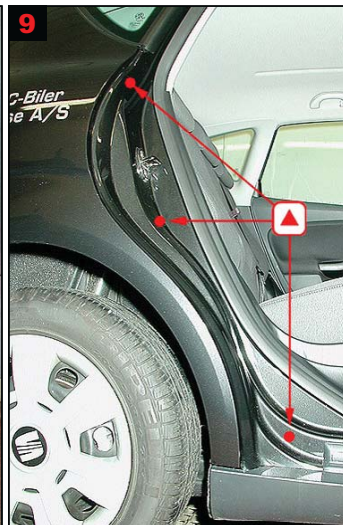
8
Rear door:
Treat via 3 drilled holes. Centre drill hole level with screws for locking device.
