Treatment diagram

Audi A4 Stationcar Model 2002

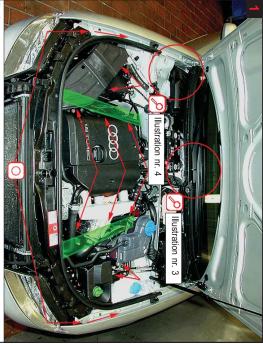
Cowl: Engine compartment:

holes. See fig 4 for correct treatment of member behind plastic plate by cowl. fluid reservoir, airfilter box and ABS distributor. Treat top members in front wings via existing Remove plastic plate for correct treatment. Fig 3. Treat along top of longitudinal members, behind

existing plugged holes. Remaining area via existing holes. Treat around radiator grille, front and rear via Bonnet lid:

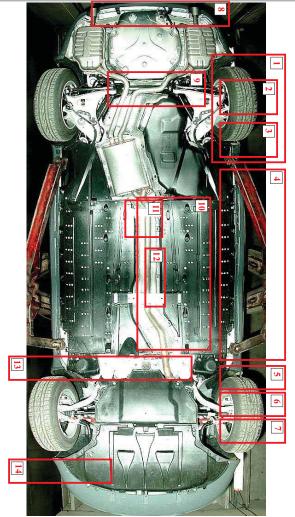
**Overview underside**

Underside

Treat via 2 drilled holes.

Wheel arch front/longitudinal member:
