BMW 1 - Serie 4D - HB

Model 2005

Floor level

Treatment diagram

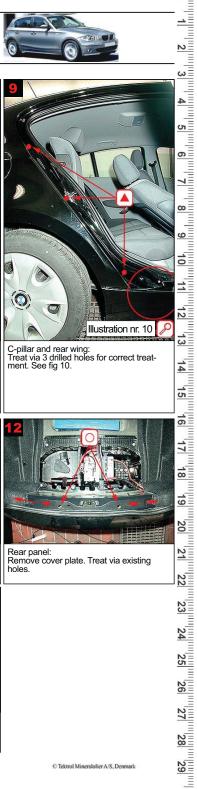
Rear wing/rear panel: Rear panel: Treat via existing holes behind lining. Rear wing: Treatment via existing lug by tail light, treat with caution in all directions.

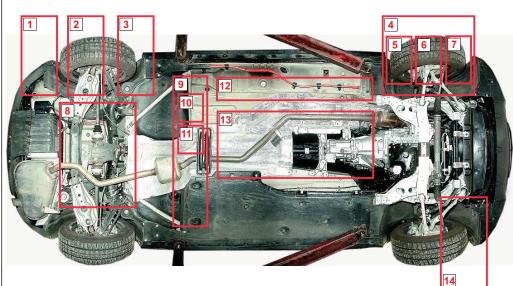
Underside
