Chery Eastar 4D - Sedan

Model 2007

Treatment diagram

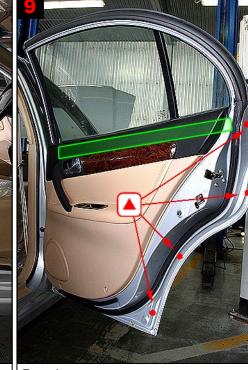
B-pillar: No treatment because of safety belt and airbag censor
