Treatment diagram

Underside

General view of underside

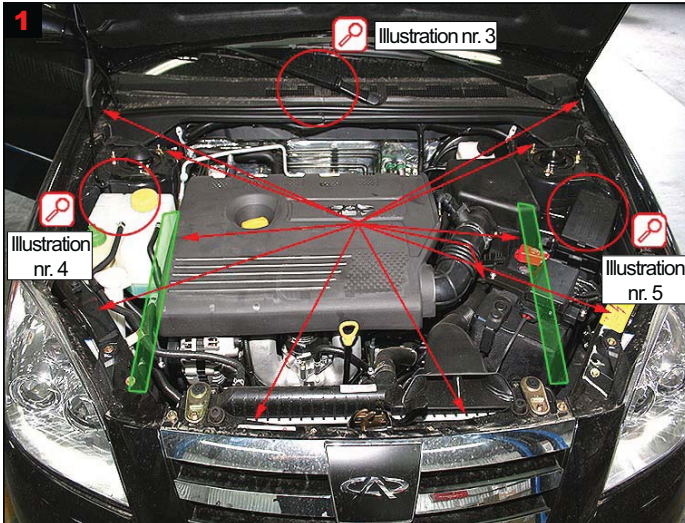
**1**  
Engine compartment:  
Cowl: Remove 5 clips, flip plastic plate - treat right across. Fig 3.  
Treatment around hinges for bonnet lid, on top of longitudinal members, under battery and air filter box, cross member above radiator, and behind spring struts.  
Treatment of reinforcements on spring struts. See fig. 4 and 5.

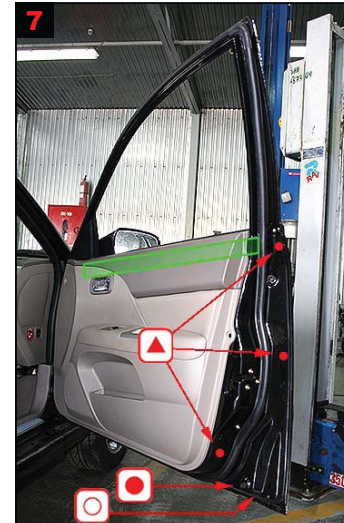
**7**  
Front door:  
Treat via 3 drilled holes, 1 existing hole and 1 existing plugged hole.  
Uppermost drill hole for inside reinforcement.

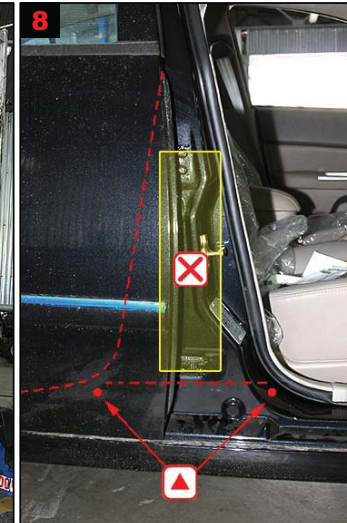
**8**  
B-pillar:  
Treat via 2 drilled holes.  
No treatment upwards because of safety belt.

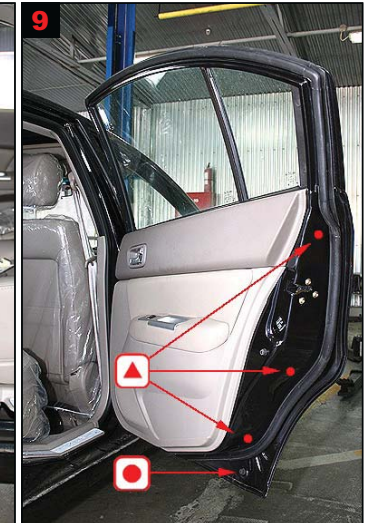
**9**  
Rear door:  
Treat via 3 drilled holes and existing plugged hole.

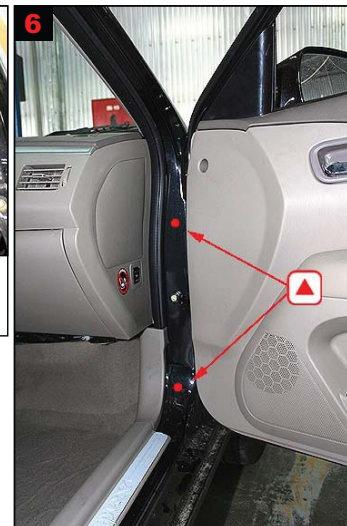
**6**  
A-pillar:  
Treat via 2 drilled holes.

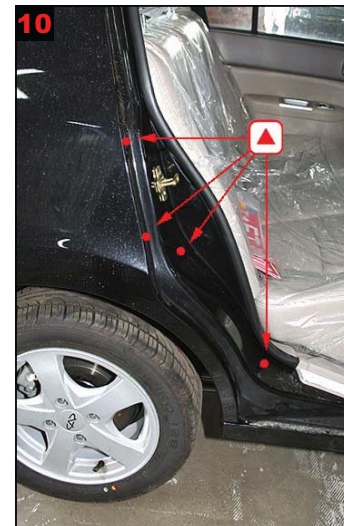
**10**  
C-pillar:  
Treatment via 4 drilled holes.  
No spraying towards cabin.

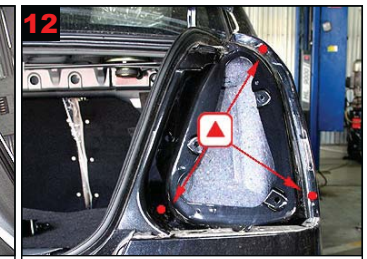
**12**  
Rear wing and reinforcement:  
Treat via 3 drilled holes.  
No spraying towards cabin.

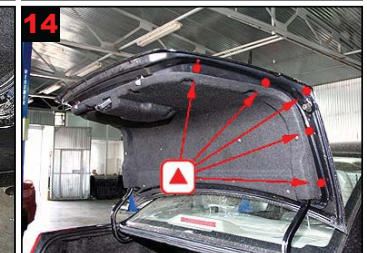
**14**  
Tailgate:  
Treat via 5 drilled holes.
