Treatment diagram

Chery Tiggo Model 2007

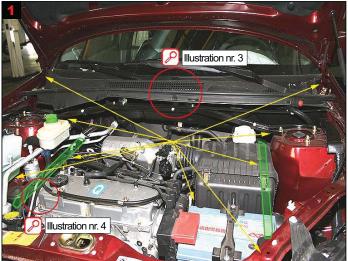
Treatment diagram

Engine compartment: Cowl: Dismantle 6 clips. Flip plastic plate and treat right across. See fig 3. Treat behind spring struts, along top of longitudinal members, under coolant reservoir, battery box, airfilter body, cross member obove radiator and around hinges for bonnet lid. Engine suspension: See fig. 4.

Bonnet lid: Treat via 3 drilled holes 4 existing holes and 1 plugged hole.

Rear door: Treatment via 4 drilled holes.

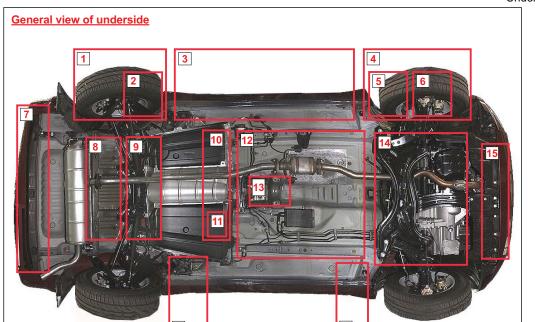
Underside

Wheel arch rear/longitudinal member: Treatment via 1 drill hole and existing holes. Reinforcement for spring: Treat via 1 drilled hole. Panel: See fig 2.
