## **Chevrolet Nubira Stationcar**

**Model 2005**

Treatment diagram

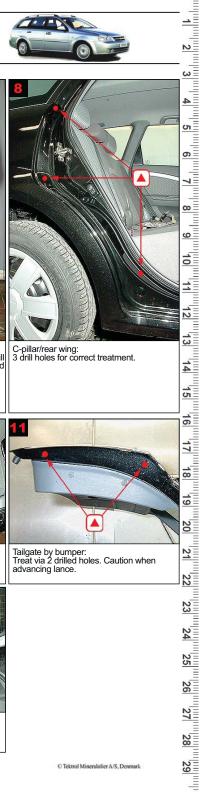
Rear panel: Treat via existing holes.

Tailgate by bumper: Treat via 2 drilled holes. Caution when advancing lance.

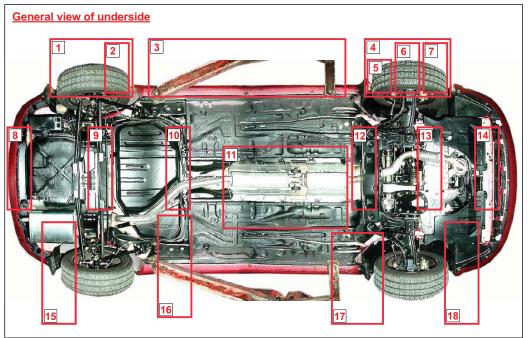
## Underside

Wheel arch front/longitudinal member/ reinforcement: Treat via 3 drilled holes and existing holes.

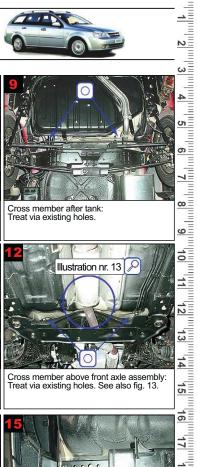
Rear panel and reinforcement on spare wheel box. Treat via existing holes and

Cross member after tank: Treat via existing holes.
