Treatment diagram

Daewoo Lacetti

Model 2004

Floor level

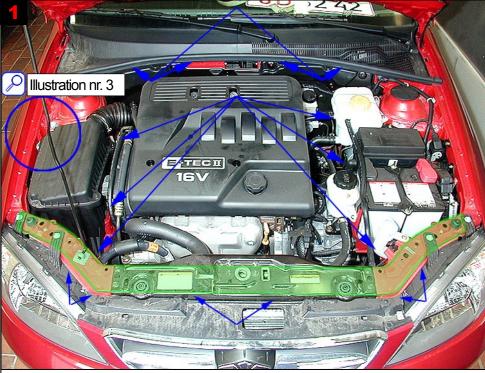
Engine compartment: Cowl: Flip plastic plate, treat with caution in underneath. Treat along top of longitudinal member, reinforcement for engine suspension right side, under airfilter and battery box, behind spring strut and treat bulb holder and locking plate. See fig. 3 for treatment of top member in front wing.

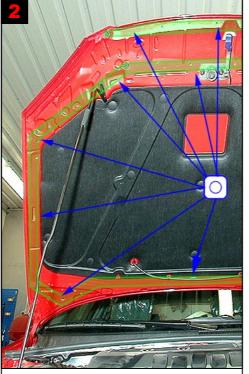
Bonnet lid: Treat via existing holes.

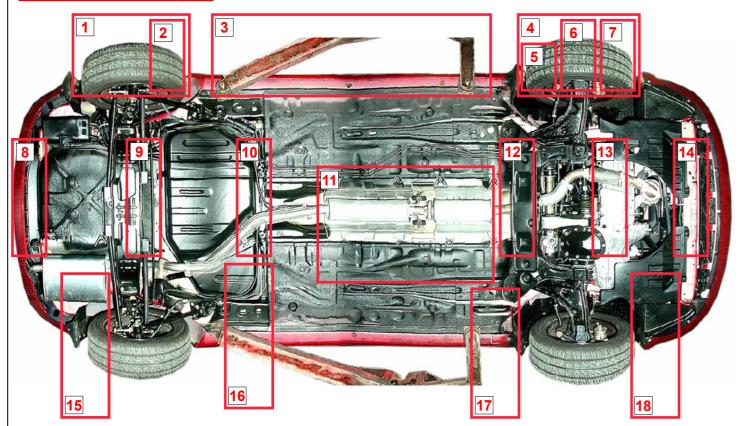
General view of underside

Wheel arch rear/longitudinal member: Treat via 3 drilled holes. See fig. 2 for cor-rect treatment of panel and C-pillar.

Wheel arch front: See fig. 5, 6 and 7.

Wheel arch rear/panel: Treat via existing plugged holes.

Panel: Treat via 3 existing plugged holes.

Wheel arch front top member: Treat via existing holes and gaps.

Wheel arch front/longitudinal member/ reinforcement: Treat via 3 drilled holes and existing holes.

Rear panel and reinforcement on spare wheel box. Treat via existing holes and gaps.

Longitudinal members centre and small cross member: Treat via existing holes behind heat shield.

Cross member under radiator: Treat via existing holes.

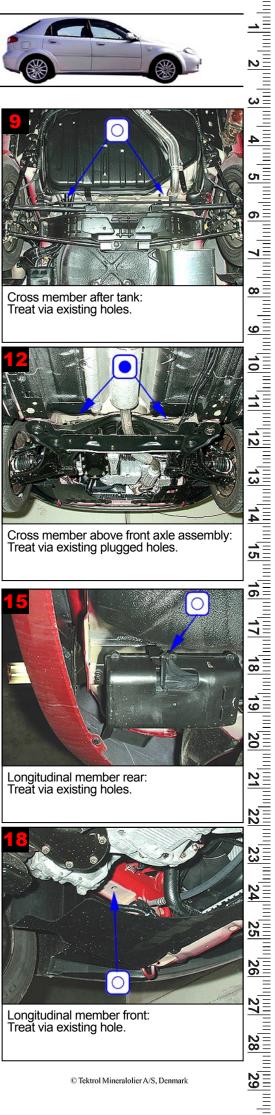
Cross member after tank: Treat via existing holes.

Cross member above front axle assembly: Treat via existing plugged holes.
