## **Daewoo Lacetti**

## **Model 2004**

Treatment diagram

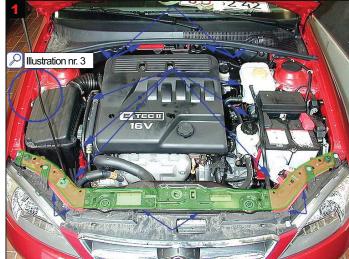
Floor level

Engine compartment: Cowl: Flip plastic plate, treat with caution in underneath. Treat along top of longitudinal member, reinforcement for engine suspension right side, under airfilter and battery box, behind spring strut and treat bulb holder and locking plate. See fig. 3 for treatment of top member in front wing.

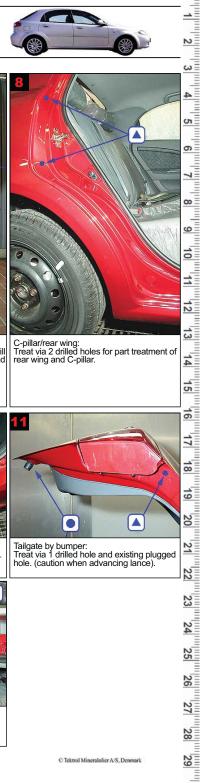
Tailgate by bumper: Treat via 1 drilled hole and existing plugged hole. (caution when advancing lance).

Tailgate side: Drill 1 hole for correct treatment.

Tailgate by roof: Remove plastic plate. Treat via existing

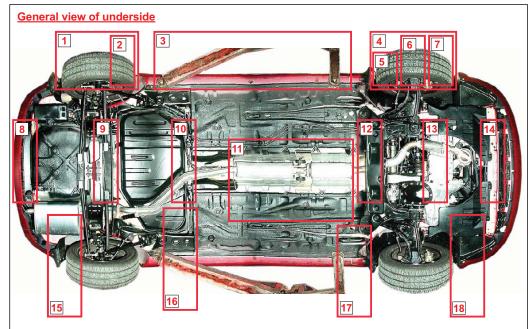
## Underside

Wheel arch front/longitudinal member/ reinforcement: Treat via 3 drilled holes and existing holes.
