Treatment diagram

Floor level

Fiat Stilo 2D - HB Model 2002

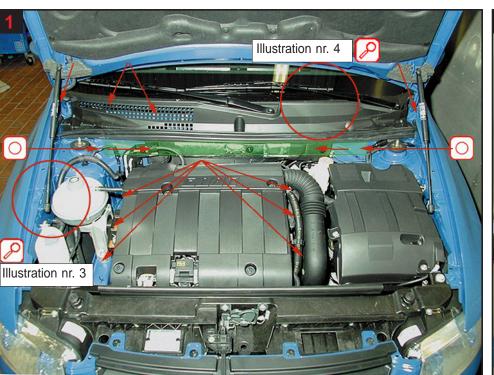
Engine compartment:

Cowl: Treat via 1 hole in plastic plate above brake fluid reservoir plus via existing holes and from sides. Fig 4.

Cross member behind engine: Treat via existing holes. Treat on top of longitudinal member and under battery box.

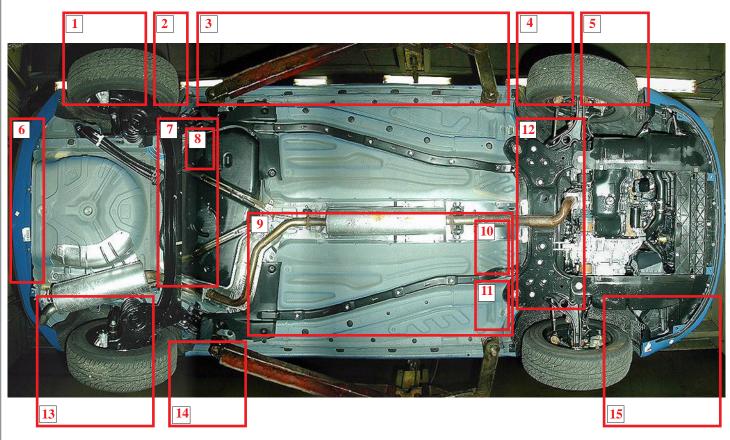
Overview underside

Wheel arch rear: Remove wheel arch liner, mount new type (plastic or aluminium).

Drill 1 hole for treatment of B-pillar and panel.

Panel: Treat via all existing plugged holes.

Wheel arch front: Flip out wheel arch liner. Treat with lance.

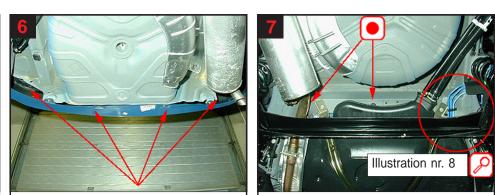
Rear panel: Treat via existing holes, and behind wheel arch liner where possible.

Fig: drilling.
