Treatment diagram

Fiat Stilo 2D - HB Model 2002

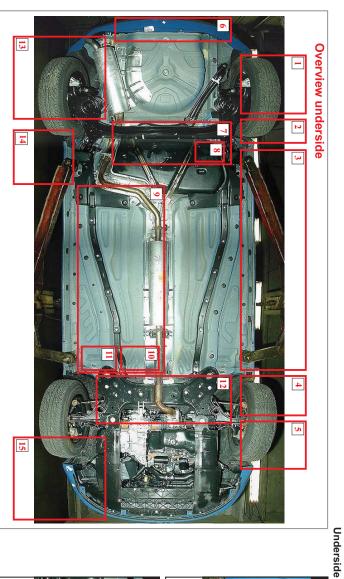
Rear panel side: Treat via 1 drilled hole. Caution when advancing lance under tail light

Rear wing:
Treat via existing hole with lance and area around tail light.
