FORD

Treatment diagram

Ford Focus Stationcar

Model 2005 Floor level

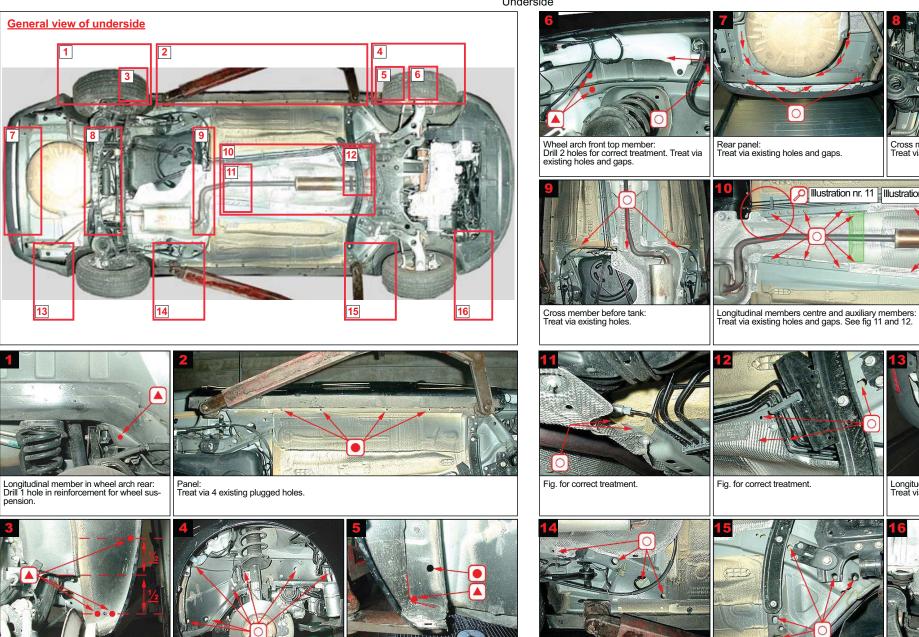
Illustration nr. 11

Underside

Wheel arch rear/panel: 2 drill holes for cor-rect treatment of inner and outer panel (treat with lance). Drill 1 hole for part treatment of C-pillar and rear wing.
