Ford Focus C-Max Model 2004 Treatment diagram

Floor level

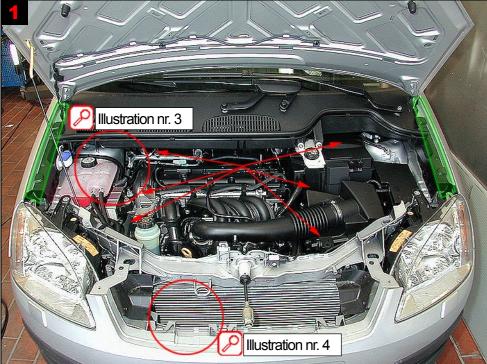
Engine compartment:
Treat behind spring struts, generally along top of longitudinal members, under coolant reservoir, battery box and airfilter body. Treat joint between front wing and wheel arch liner.
U-member behind bumper: See fig 3 and 4.

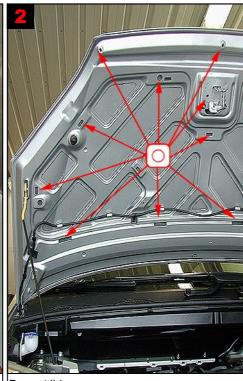
Bonnet lid: Treat via existing holes.

Fig. for correct treatment of reinforcements on spring struts.

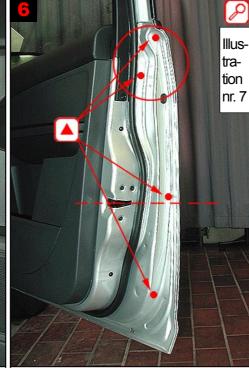
Front door:
4 drill holes for correct treatment. See fig. 7 for correct top drilling. Centre drilling: Treat via 1 drilled hole above lock mounting. Drill close to door plate.

Front door sectional view: Drill between spot welds 1 and 2.

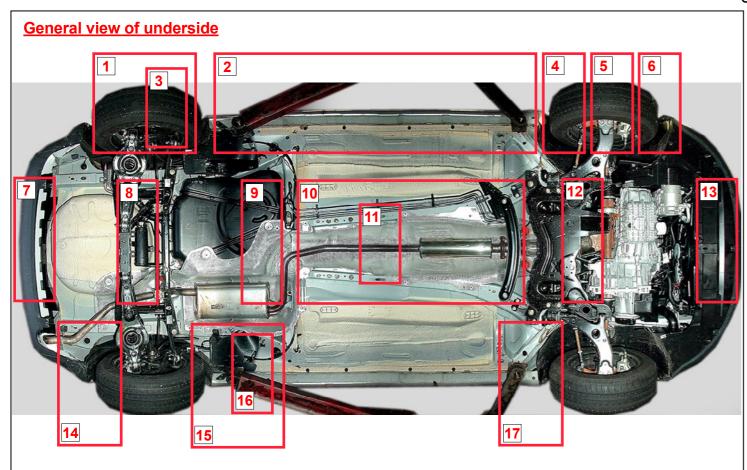
Underside

Wheel arch rear: Remove/flip wheel arch liner. 1 drill hole to treat panel, treat with lance. See fig 3 for correct treatment.
