Treatment diagram

Ford Focus C-Max

Model 2004

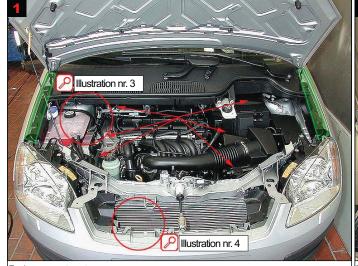
Engine compartment: Treat behind spring struts, generally along top of longitudinal members, under coolant res-ervoir, battery box and airlifter body. Treat joint between front wing and wheel arch liner. U-member behind bumper: See fig 3 and 4.

Bonnet lid: Treat via existing holes.

Front door sectional view: Drill between spot welds 1 and 2.

B-pillar: Treat via 1 drill hole below lock mounting.

Rear door sectional view: 2nd drill hole: Drill level with plate fold.

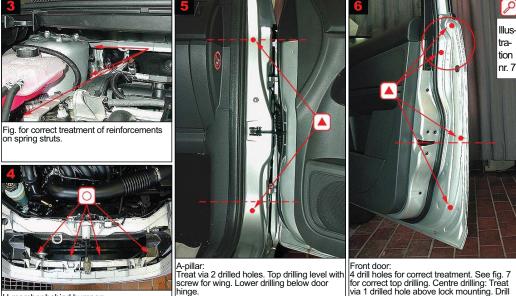
Rear door: 4 drill holes for correct treatment. See fig. 10 for drilling at correct level. Centre drilling: Drill level with screw.

U-member behind bumper: Treat whereever possible.

Front door: 4 drill holes for correct treatment. See fig. 7 for correct top drilling. Centre drilling: Treat via 1 drilled hole above lock mounting. Drill close to door plate.

Rear panel: Treatment via existing plugged holes (clips).

Rear wing: Treat via 1 drilled hole above tail light.

Tailgate side: 4 drill holes for correct treatment. **Caution** when advancing lance.

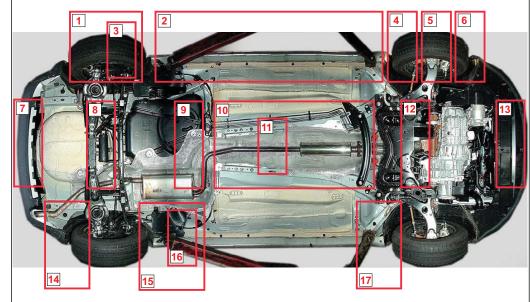
General view of underside

- Wheel arch rear: Remove/flip wheel arch liner. 1 drill hole to treat panel, treat with lance. See fig 3 for correct treatment.

Panel: Treatment of inner panel via 4 existing plugged holes. 2 drill holes for correct treatment of inner and outer panel (treat with lance). See fig. 3 and 6 for correct treatment.
