Treatment diagram

## **Chrysler Voyager MPV** Model 2001

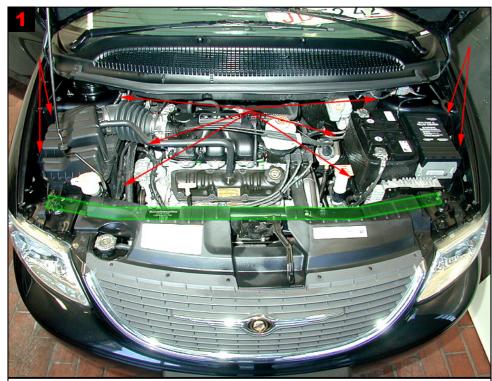
## Engine compartment:

No treatment of cowl. Treatment on top of longitudinal members, behind spring struts, under battery, fuse- and air filter box. Treatment of locking plate and cross member.

Bonnet lid: Treatment of front and sides via existing holes. 2 plugged holes by wind screen (clips for lining) for correct treatment.

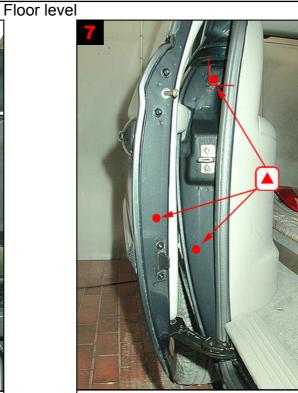
Side door top member: Treat via 1 drilled hole.
