Treatment diagram

Hyundai Sonata 4D - Sedan

Model 2005

Floor level

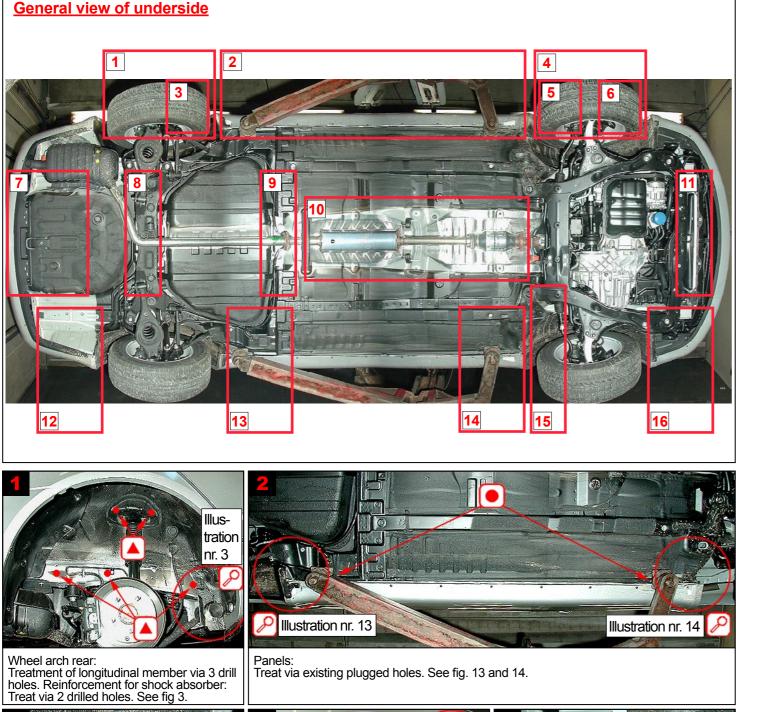
Underside

Wheel arch rear/panel: Treat via 1 drilled hole and existing plugged holes. Drill level with plate flange.

Wheel arch front/longitudinal member: Treat via 1 drilled hole. Treat via existing and plugged holes. See fig 6 for drilling at correct level.

Wheel arch front/panel: Treat via 2 drilled holes as well as via exist-ing plugged hole.

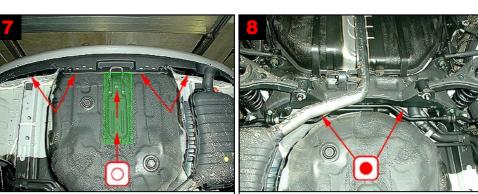
Wheel arch front: Top member: Treat via existing holes and gaps. Reinforcement: Treat via 1 drilled hole.

Rear panel and reinforcement: Treat via existing holes. Treat via gap be-tween bumper and panel.
