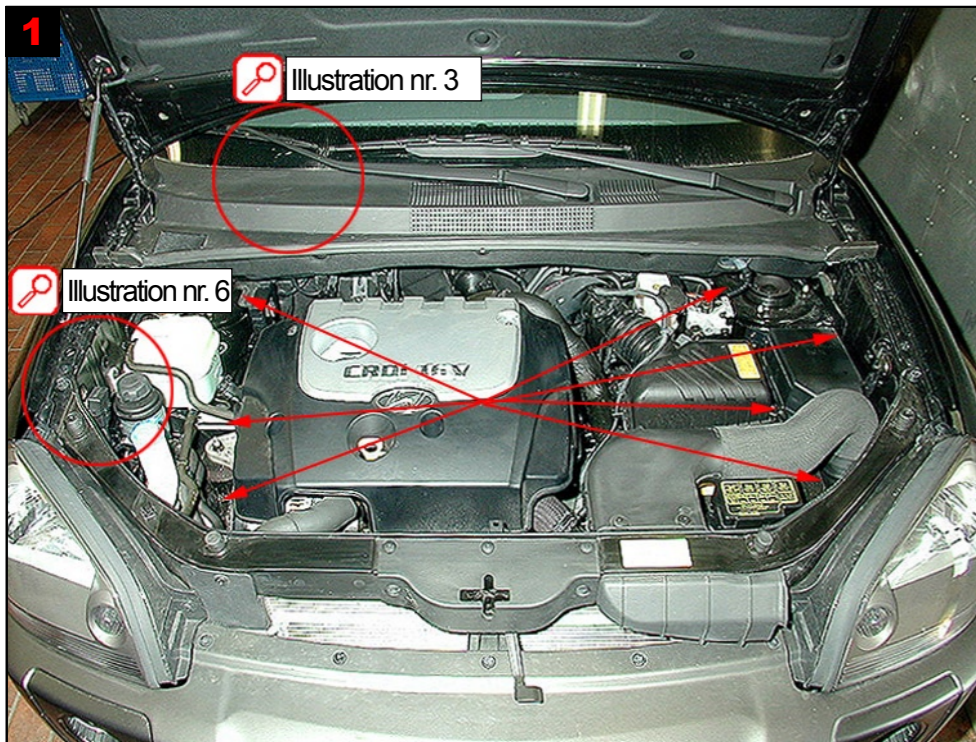
Engine compartment:
Cowl: Flip plastic plate, treat with caution underneath.
Treat behind spring struts, generally along top of longitudinal members, under coolant reservoir, battery box and airfilter body. See fig. 3 and 6 for correct treatment.

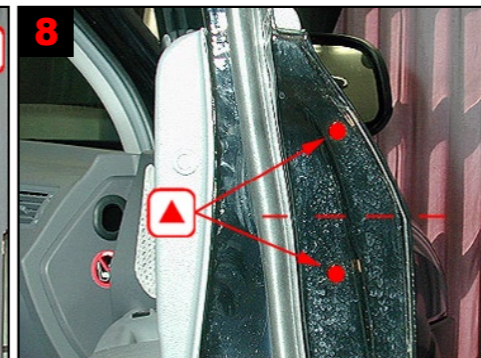
Front door sectional view:
Fig. for correct treatment.

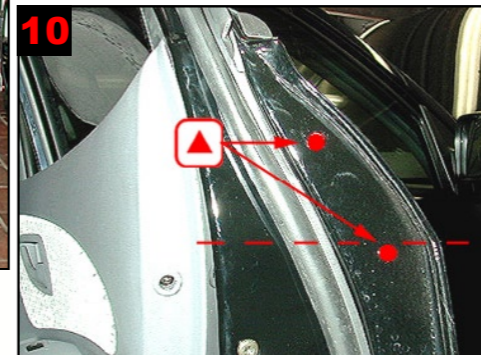
Rear door sectional view:
Fig. for correct treatment.

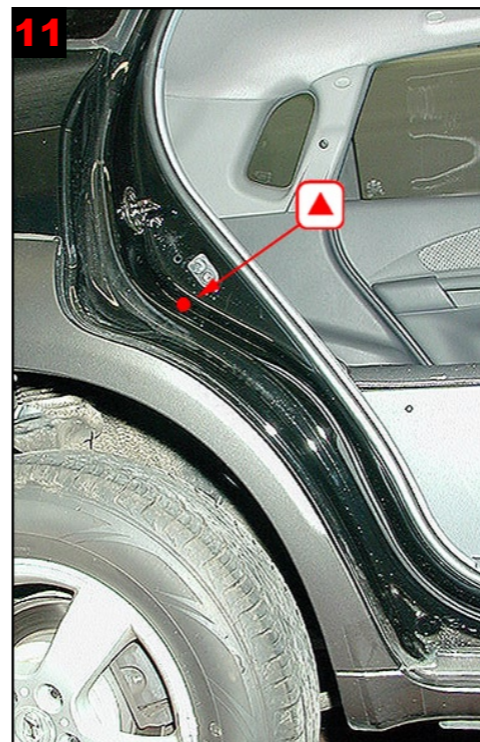
C-pillar/rear wing:
Drill 1 hole for part treatment of C-pillar and rear wing. See fig 12.

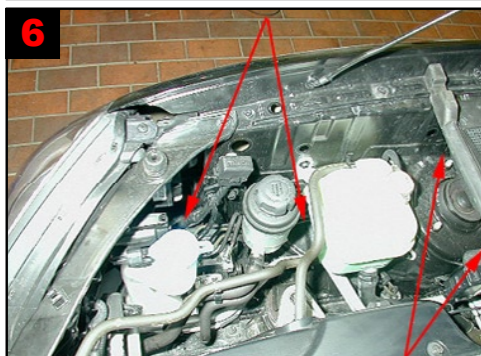
Engine compartment - sectional view:
Fig. for correct treatment.
