Mazda 323 4D - Sedan Model 2002

Treatment diagram

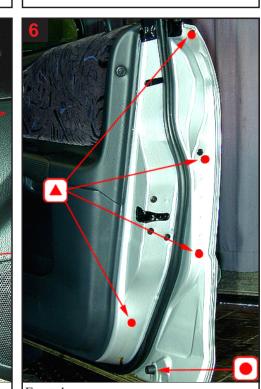
A-pillar/front wing: A-pillar: Treat via 3 drilled holes. Front wing: Treat via gap between A-pillar and wing with lance.

Treat via existing holes. Holes in sides

and bottom is behind lining.

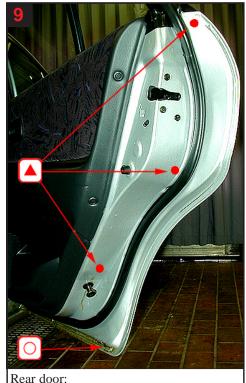
B-pillar: Remove door switch. Treat via existing hole.

Treat via 3 drilled holes and existing drain hole rear.

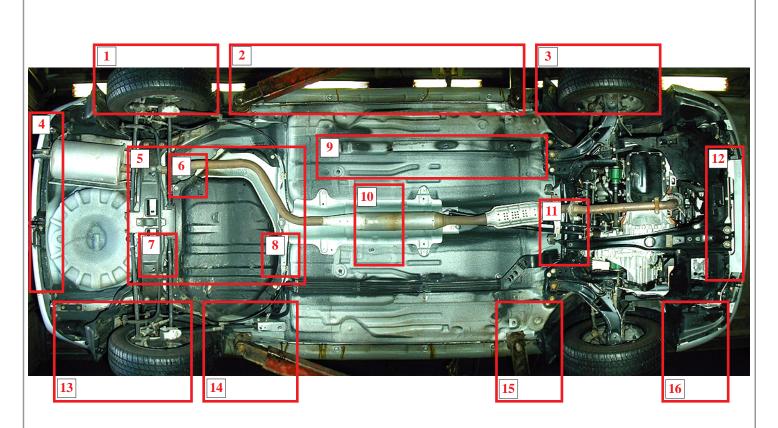
Overview underside

Wheel arch rear: Treat via 4 existing plugged holes.
