Treatment diagram

Mazda 323 F Model 2000

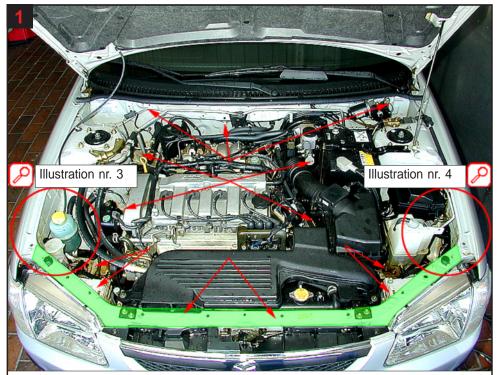
Floor level

Engine compartment:

Cowl: Treat via 3 existing holes sealed with tape in car's colour. Treat under battery and airfilter box, on top of longitudinal member, behind head lights and spring struts plus locking plate. See fig 3 and 4 for correct treatment.

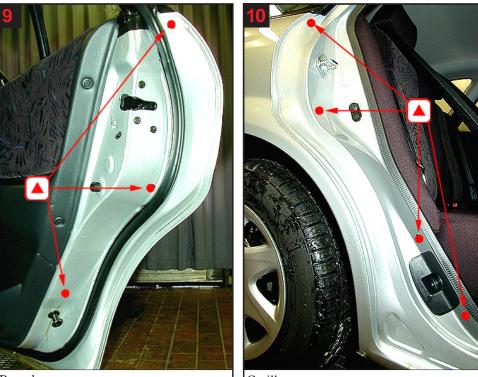
Rear door: 3 drill holes for correct treatment.

B-pillar: Treat via existing gap by door strap.

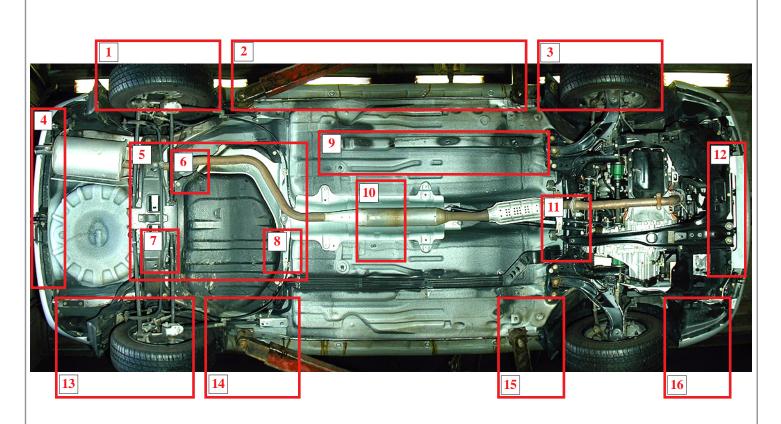
Overview underside

Wheel arch rear: Treat via 4 existing plugged holes.

Wheel arch front: Drill 1 hole plus 2 existing holes sealed by tape in car's colour.

Panels: Treat inner panel and centre panel via 4 existing plugged holes (treat outer panel from floor level).

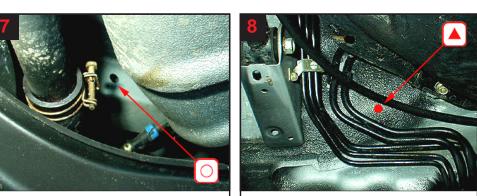
Reinforcement between tank and rear axle assembly. Treat via existing holes.
