Engine compartment:

Treatment diagram

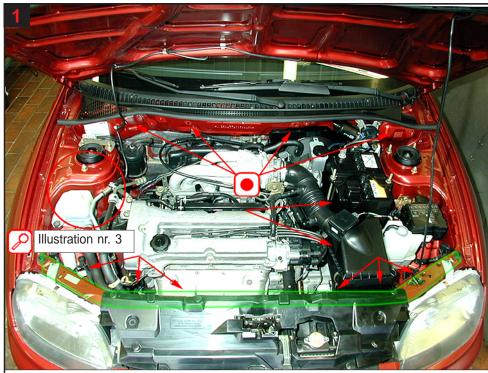
Floor level

Cowl: Treat via existing holes. Treat along top of longitudinal member, reinforcement for engine suspension right side, under airfilter and battery box, behind spring strut and treat bulb holder and locking plate. See fig 3 for correct treatment of top member in front wing.

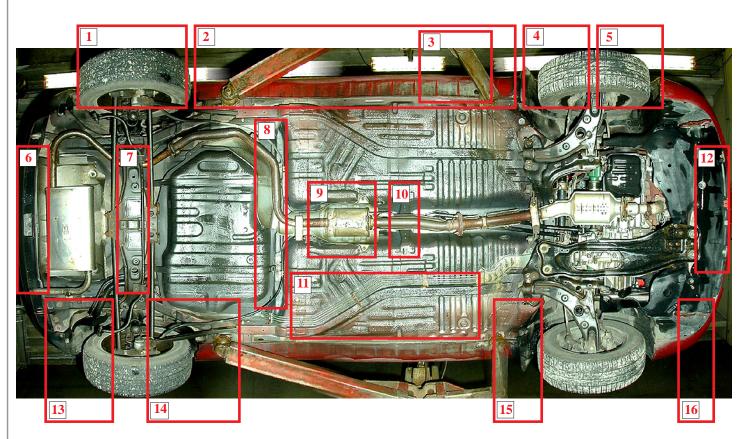
Underside

Wheel arch rear: C-pillar/panel: Treat via existing plugged hole.

Panel: Treat via 2 drilled holes as well as via 2 existing plugged holes. If there is plating for centre panel by holes and plugs drill free hole. See fig 3 for drilling at correct level.
