Treatment diagram

General view of underside

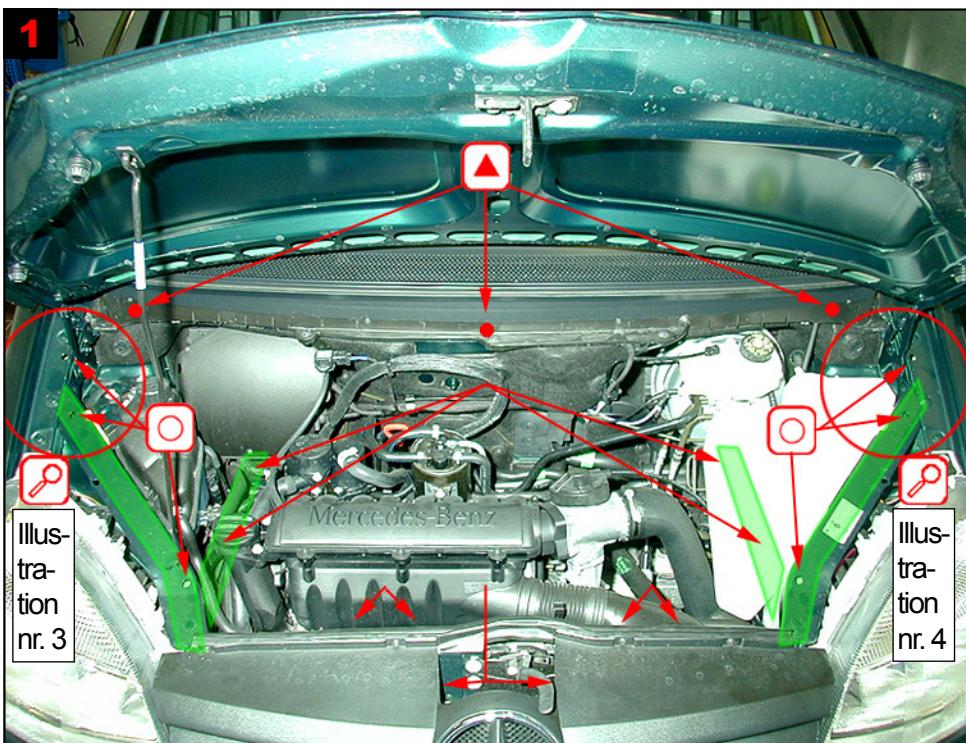
Engine compartment: Cowl:
 Treatment via 3 drill holes in plastic plate (treat with caution). Treatment of top members in wings, on top of longitudinal members, under fluid reservoir, ABS distributor. Treatment of auxilliary members and locking plate. See fig 3 and 4 for correct treatment.

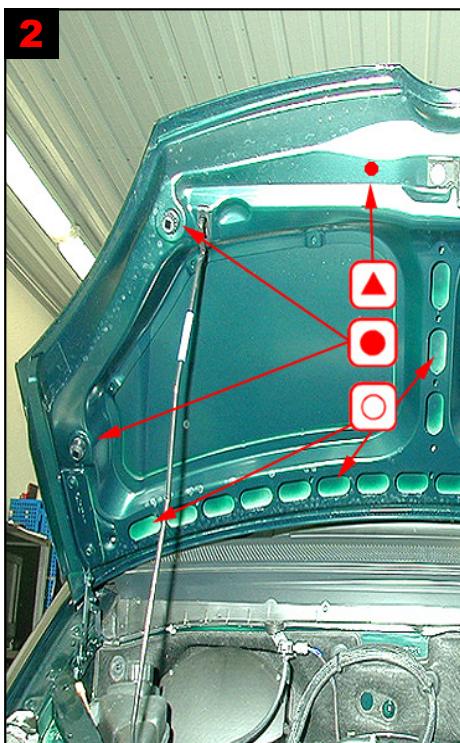
Bonnet lid:
 2 drill holes in front. 2 existing plugs each side. Remaining area via existing holes.

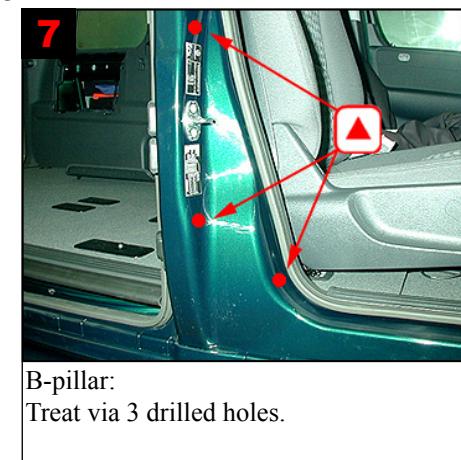
B-pillar:
 Treat via 3 drilled holes.

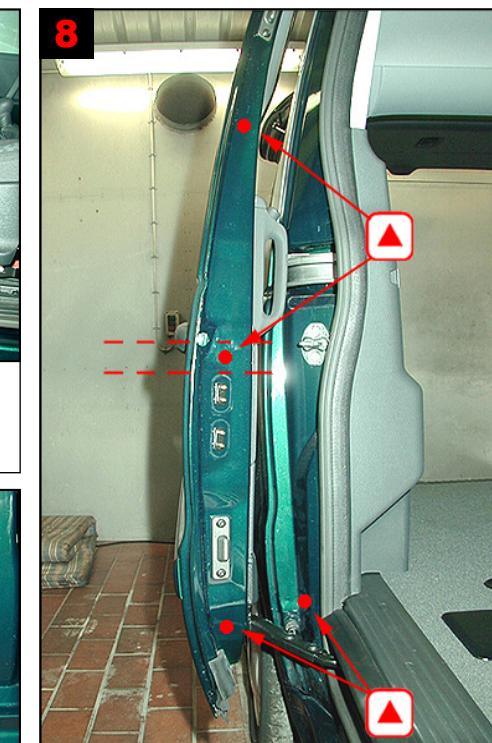
C-pillar/sliding door: C-pillar:
 Treatment via 1 drill hole right above mounting for sliding rail. Sliding door: Treat via 3 drilled holes. Drill hole centre is drilled between screw for handle and light switch.

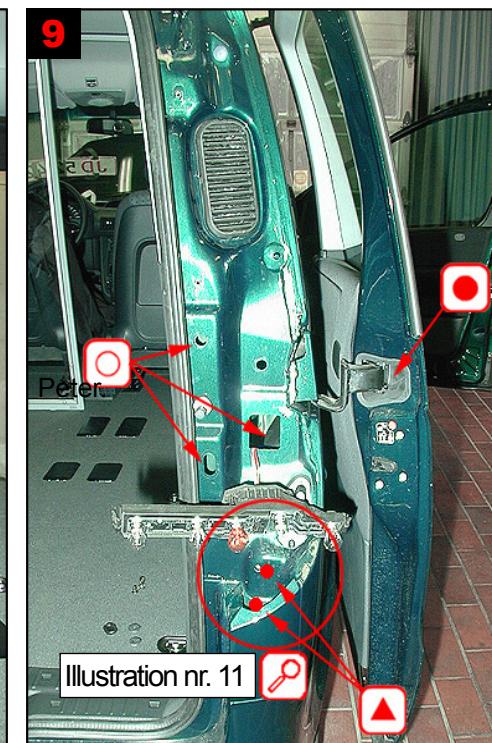
D-pillar/sliding door rear:
 Sliding door rear: Treatment via plugged hole by mounting for sliding rail. D-pillar: Remove tail light. Treat via existing holes. See fig. 11 for correct drill holes.

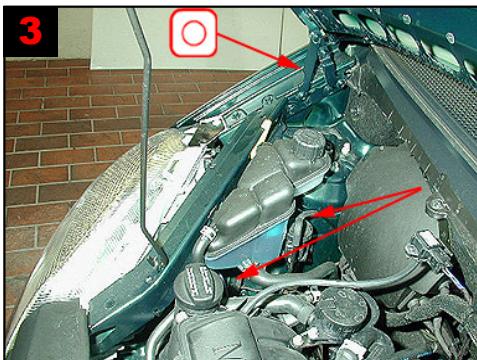
Engine compartment - sectional view:
 Treatment under fluid reservoir and behind head lamp and existing hole for top member in wing.

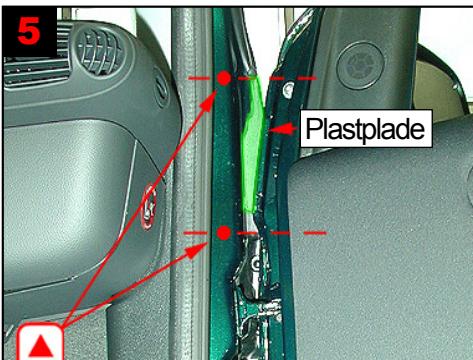
A-pillar:

Treatment via 4 drilled holes. Uppermost drill hole level with top of plastic plate. 2nd. drill hole right above door hinge. Lower drill holes: 0

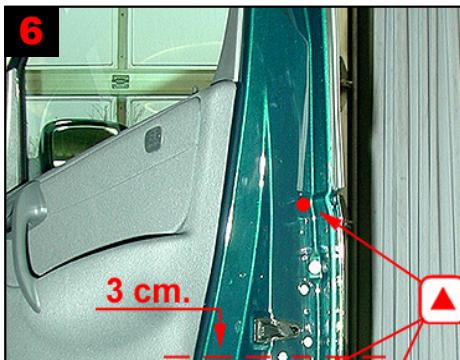
Front door:

Treat via 3 drilled holes. Centre drilling. Drill 3 cm below screw for door lock.

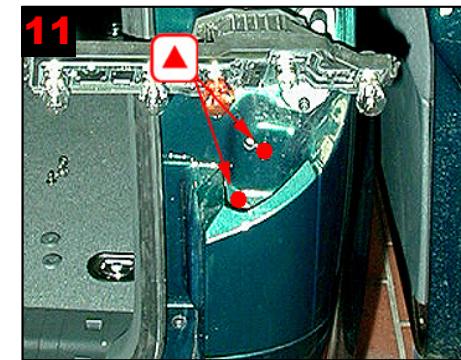
Rear wing and rear panel:
 Treat via 2 drilled holes.

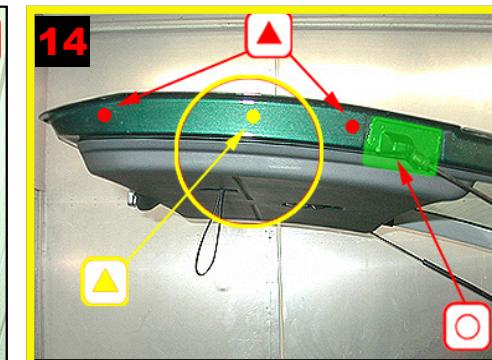
Tailgate side: Treatment of reinforcement via existing hole. Right side: Treat via 2 drilled holes. **Left side:** Treat via 1 drilled hole.

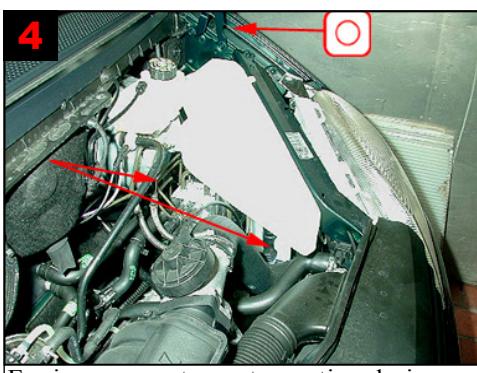
Engine compartment - sectional view:
 Treatment under ABS distributor and behind head lamp and existing hole for top member in wing.

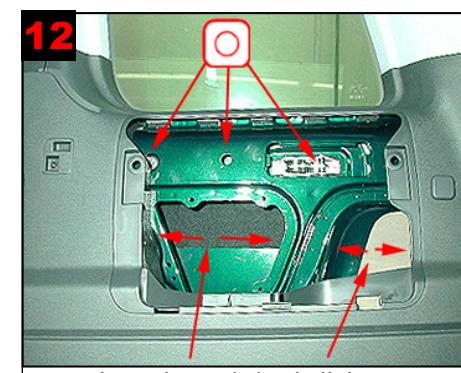
Rear wing: Dismantle lug in lining. Treatment of top member via existing holes and rear wing via existing gaps, treat in all directions.

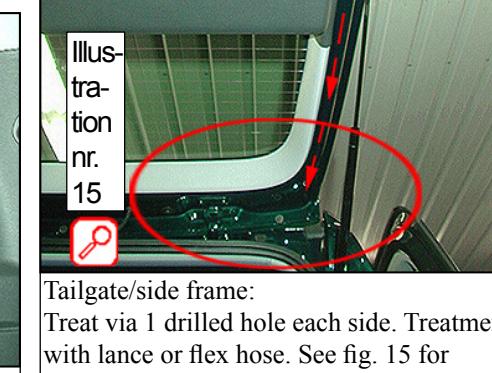
Tailgate/side frame:
 Treat via 1 drilled hole each side. Treatment with lance or flex hose. See fig. 15 for treatment of tailgate by roof and slide door.

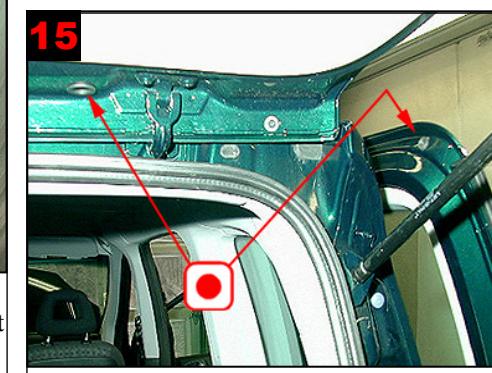
Tailgate by roof/sliding door: Tailgate: Treatment via 2 plugged holes. Sliding door: Treatment via existing plugged hole in frame.

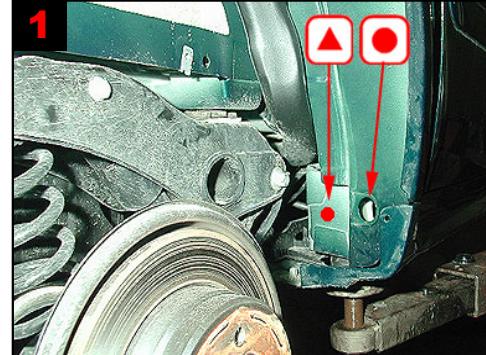
Wheel arch rear:
Treatment of panel via 1 drill hole and
existing plugged hole.

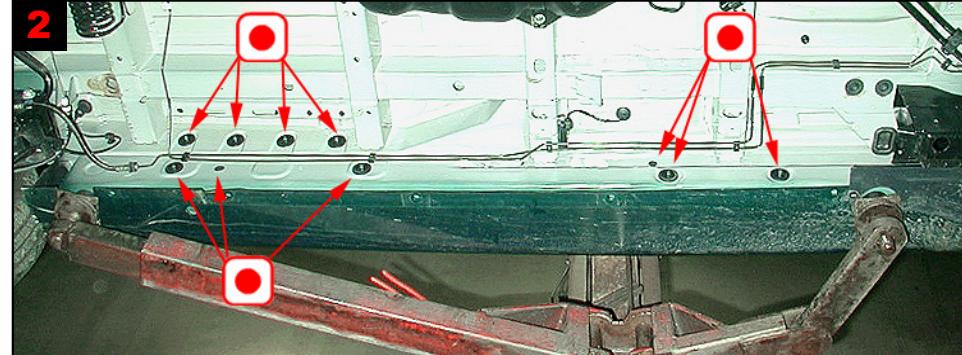
Panel:
Treatment via existing plugs (10 plugs each side).

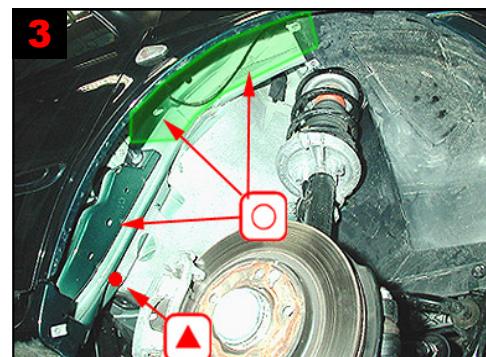
Wheel arch front: Dismantle rear liner.
Treatment of top member and auxiliary member
via existing holes. Panel: Treat via 1 drilled hole.

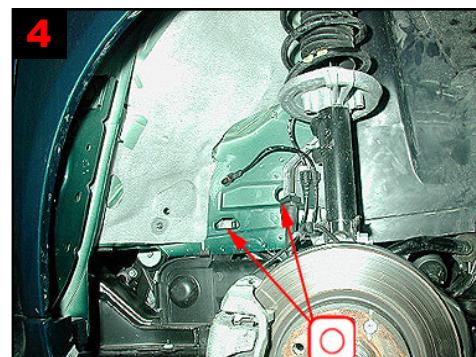
Wheel arch front/longitudinal member:
Treat via 2 existing holes.

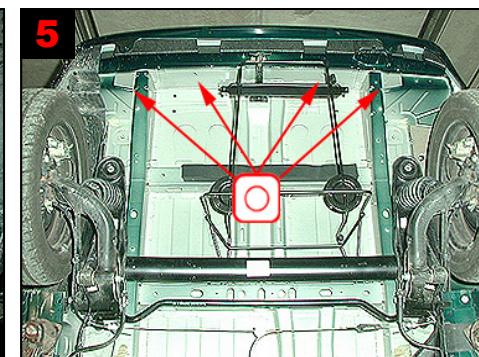
Rear panel:
Treat via existing holes.

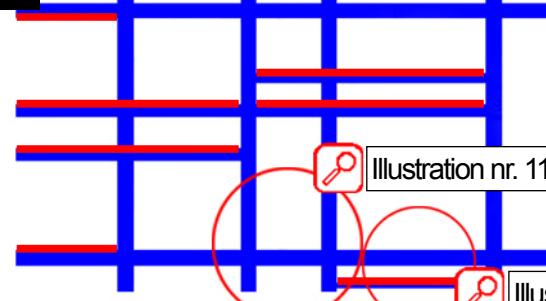
7

Body frame: Fig. 7: Treat as separate units. Treatment via existing holes and gaps - as existing gaps can be very small, additional drilling close to gap may be necessary. See fig 11. Several longitudinal members (marked red on fig. 7) are double members. See fig 12.

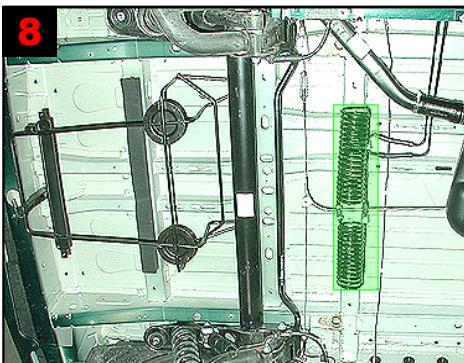
Fuel radiator:
Cover radiator from oil.

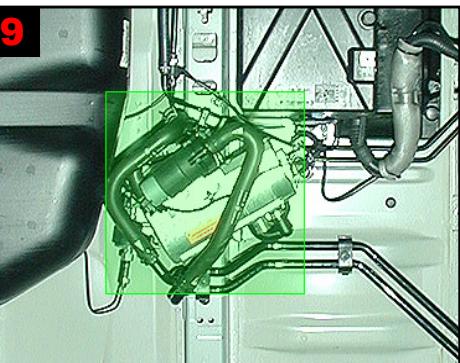
Cabin heater:
Cover heater from oil.

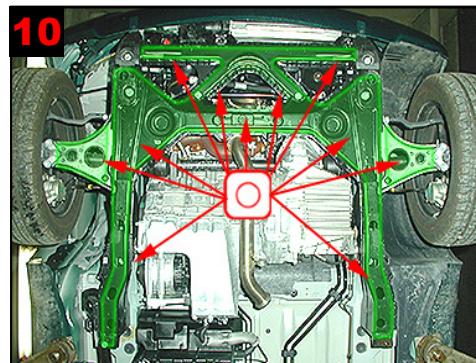
Front axle assembly:
Treat via existing holes.

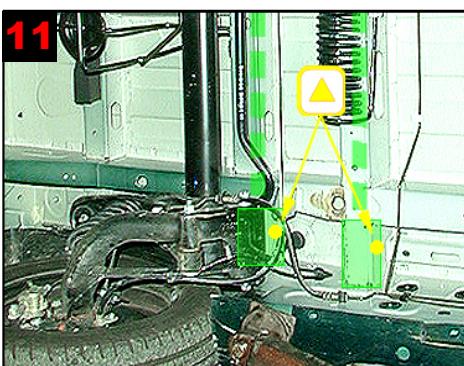
Cross members side fittings: Treatment
via existing holes and gaps - as existing
gaps can be very small, additional
drilling close to gap may be necessary.

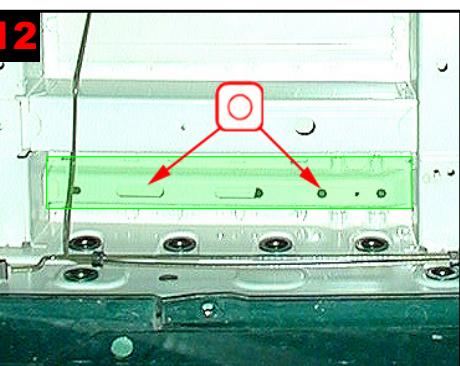
Double members:
Several members are filled with foam
rubber - remove it if possible.

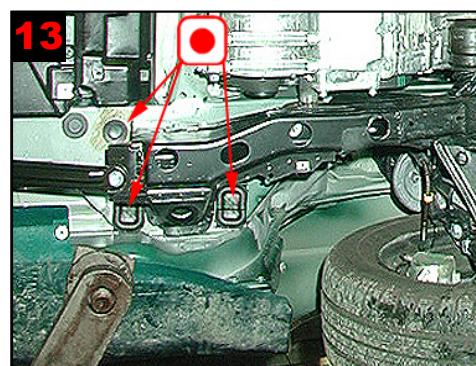
Longitudinal member before wheel arch
front: Treat via existing plugged holes.
