Treatment diagram

Mercedes Vito Model 2004

Mercedes Vito

Model 2004

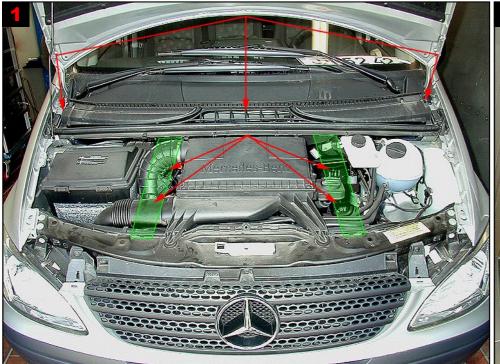
Floor level

Engine compartment: Cowl: Treat via existing holes and from sides. Treat on top of longitudinal member and under battery box.

Bonnet lid: Treat via existing and plugged holes. By windscreen: Flip up lining. Treat via existing

B-pillar: Treatment via 2 existing plugs. Remove door switch / door stop. Treat via existing

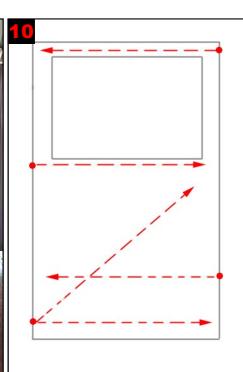
Side door: 4 drill holes for correct treatment. Drill hole 5 cm. below door switch.

Side door: Fig. for correct treatment. (caution when advancing lance).

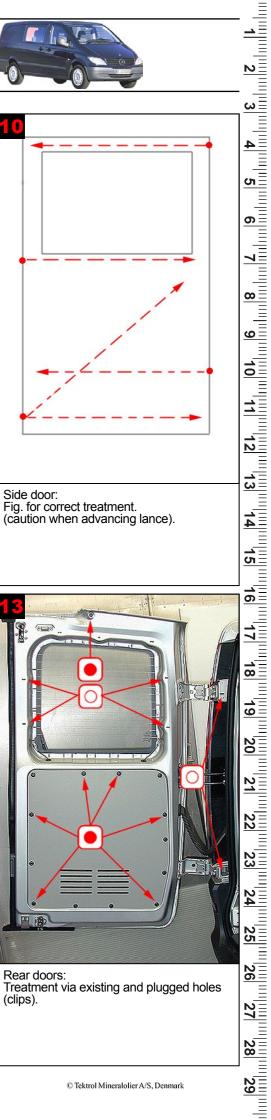
A-pillar: Treat via 3 drilled holes. See fig. 4.

A-pillar: Treat via 1 drilled hole under rubber strip.

Front door top member: Fig: drilling at correct level.

Area by sliding rail: Treat from each s ide.

Area by sliding rail: Treat from each side.

D-pillar/roof frame: Treat via existing holes.

Rear doors: Treatment via existing and plugged holes

Front door bottom:
Treat via existing holes in door bottom. Treat with lance. (caution when advancing lance).

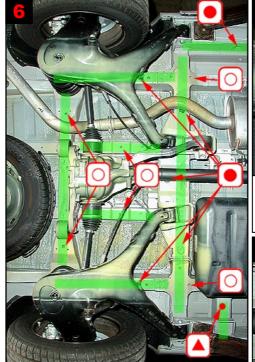
Cross member and auxiliary members above rear axle assembly:
Treat via existing and plugged holes. See fig 7.

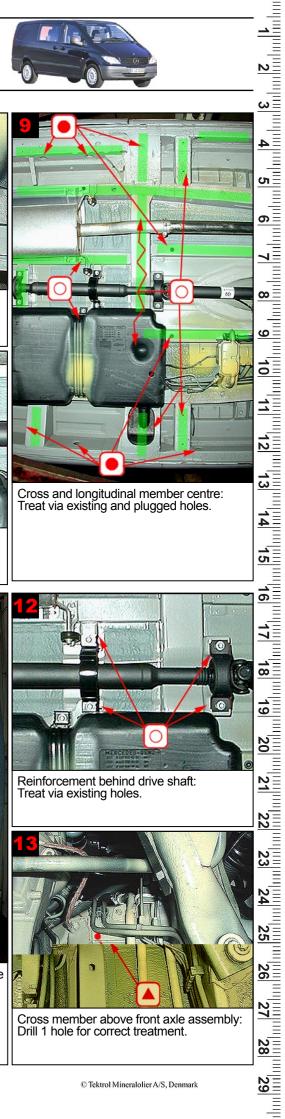
Reinforcement for wheel suspension. Treat via existing aperture.

Reinforcement behind drive shaft: Treat via existing holes and gaps.

Cross and longitudinal member centre: Treat via existing and plugged holes.

Wheel arch rear: Treat behind wheel arch liner where pos-

Longitudinal member/reinforcement in wheel arch front:
Treat via existing holes.

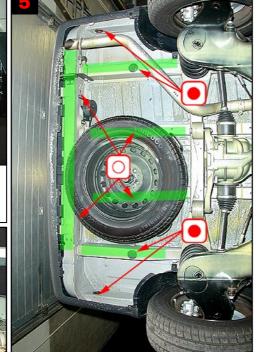
Rear panel and reinforcement: Treat via existing and plugged holes.

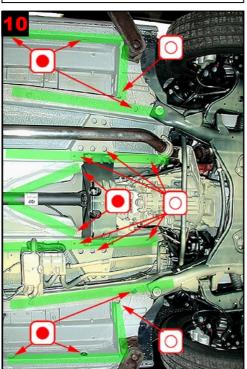
Longitudinal, cross and auxilliary members: Treat via existing and plugged holes.

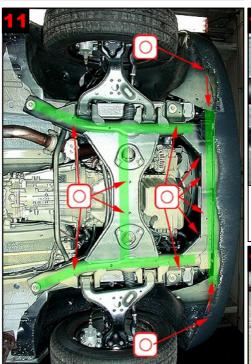
Reinforcement under radiator and front axle assembly:
Treat via existing holes.
