Mitsubishi Grandis

Model 2004

Treatment diagram

Mitsubishi Grandis Model 2004

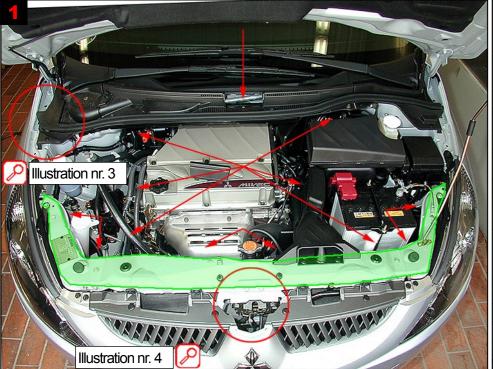
Floor level

Engine compartment:
Cowl: Treat via existing lug in all directions.
Treatment on top of longitudinal members, behind spring struts, under battery and fuse box and treatment of reinforcement for engine suspension. Treatment of locking plate via existing holes and up under. See fig. 3 and 4 for correct treatment of top member in wing and engine compartement.

Bonnet lid: Treat via existing holes and gaps.

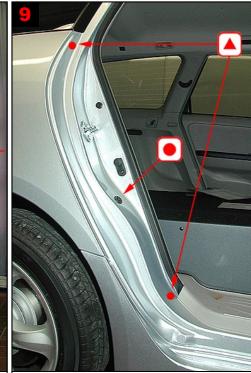
B-pillar: Treat via 1 drilled hole and existing plugged

Rear door: Treat via 3 drilled holes and existing plugged hole. Centre drill hole level with door lock.

C-pillar/rear wing: Correct treatment via 2 drilled holes and via existing plugged hole.

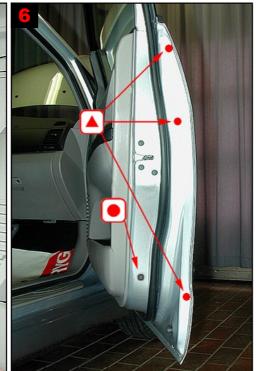
Engine compartement/top member: Treat via existing holes.

A-pillar: Treat via 1 drilled hole and 3 existing plugged holes.

Front door: Treat via 3 drilled holes and existing plugged

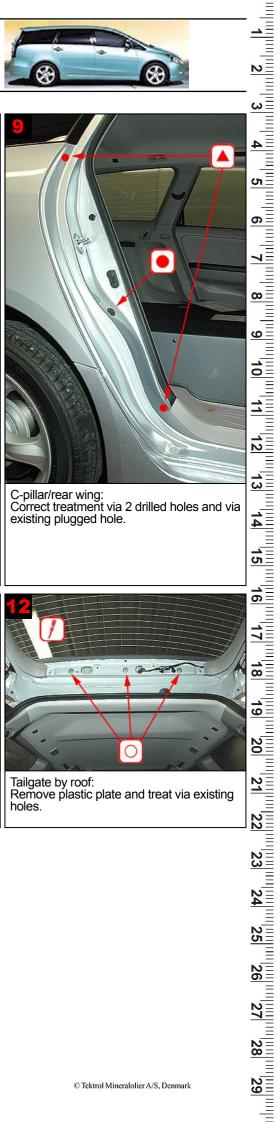
Rear wing: Remove tail light. Treat via 2 drilled holes as well as via existing plugged hole. (clips)

Tailgate side: Drill 2 holes for correct treatment.

Tailgate by roof: Remove plastic plate and treat via existing

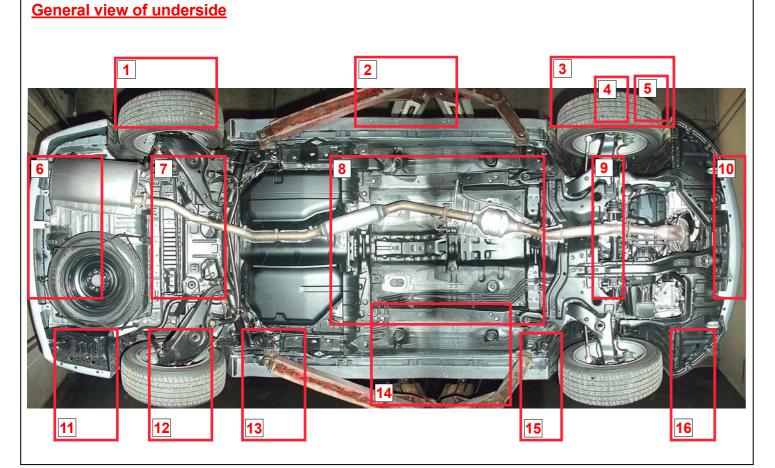
Underside

Wheel arch rear/panel: Treat via 1 drilled hole and existing plug on

Panels: Treat via 3 existing plugged holes.

Wheel arch front/longitudinal member: Treat via 1 drilled hole and existing hole. See fig. 4 for treatment of panel. See fig 5 for treatment of top member.

Panel: Correct treatment via 2 drilled holes and via existing plugged hole.

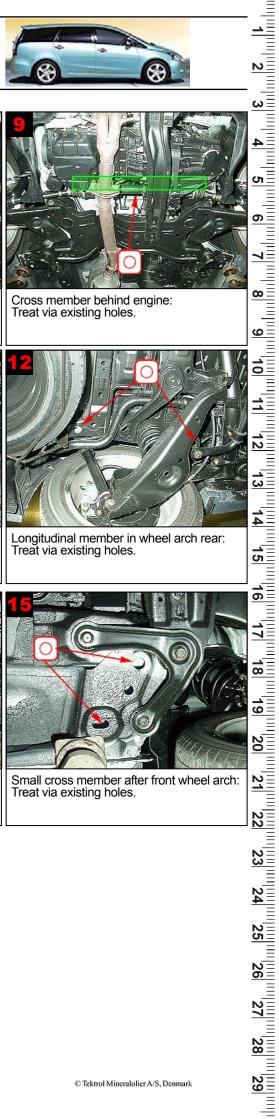
Top member: Treat via existing holes and gaps.

Rear panel/reinforcement: Treat via existing holes and gaps.

Cross members: Treat via existing holes.

Cross members centre: Treat via existing holes.

Cross member behind engine: Treat via existing holes.

Cross member under radiator: Treat via existing holes and gaps.

Longitudinal member rear: Treat via existing holes.

Longitudinal member in wheel arch rear: Treat via existing holes.

Longitudinal member before wheel arch rear: Treat via existing holes.

Longitudinal member centre: Treat via existing holes.

Small cross member after front wheel arch: Treat via existing holes.
