Treatment diagram

Opel Meriva MPV Model 2003

Floor level

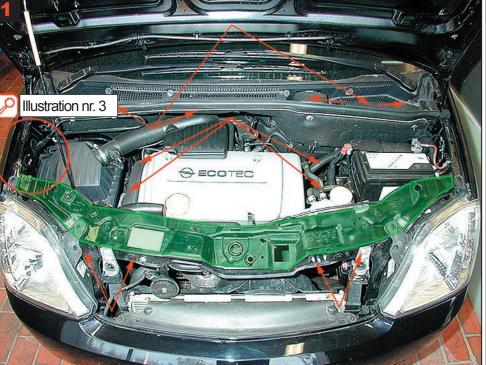
Engine compartment: Cowl: Flip plastic plate, treat with caution in underneath. Treatment on top of longitudinal member and battery and air filter box. Treatment up under locking plate and side fittings by radiator.

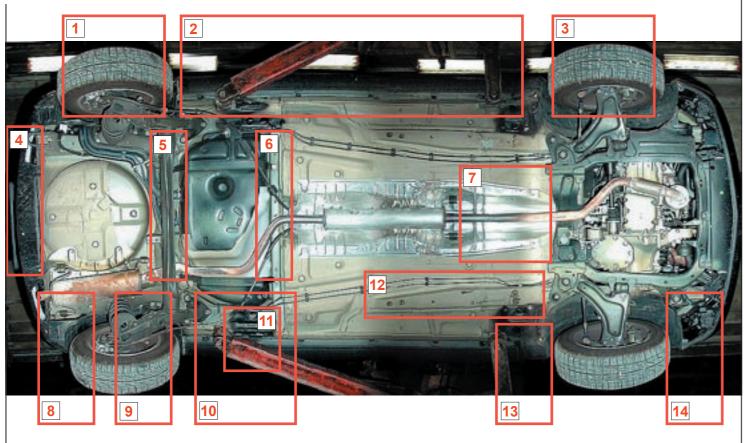
Wheel arch rear/panel: Flip out wheel arch liner. Treat via 3 existing plugged holes. Treat behind wheel arch liner where possible.

Panels: Treat via 6 plugged holes.

Wheel arch front: Flip out wheel arch liner. Treat via existing holes. Treat behind wheel arch liner where possible.
