Treatment diagram

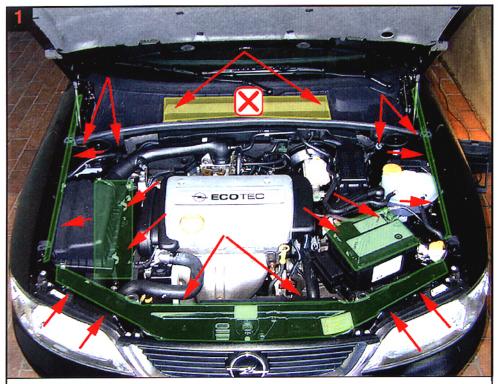
Engine Compartment.

Cowl. Lift up and tilt plastic lid, no spraying towards pollen filter.

Engine compartment. Under air filter housing and under battery box, behind spring struts and along the join between front wing/inner wing.

Locking plate. Treat from down and upwards plus existing holes.

Protect headlamps against oil.

Bonnet. Treatment via existing holes. Carefully tip out the sound-insulating cover.

Front wings. Treatment of top member with flex-hose.

Front door. Treatment via existing hole by door stop arm.
