Opel Astra 4D - HB

Model 2004

Treatment diagram

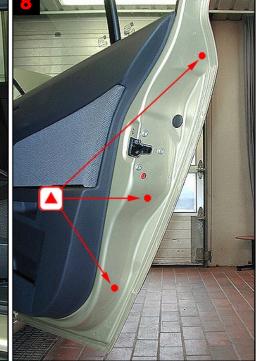
B-pillar: Treat via 1 drilled hole and existing plugged hole. Drill 1 hole 5 cm. above lock mounting.

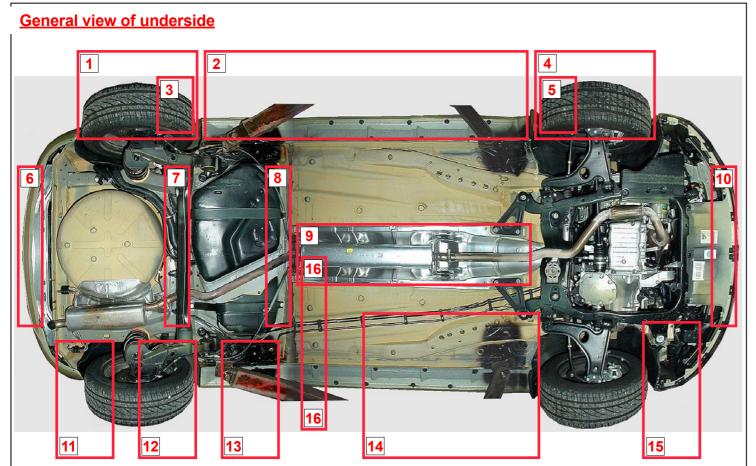
Underside

Wheel arch rear/rear wing: Treat via 2 existing plugged holes on back. See fig 3 for treatment of panels and wheel arch.

Panel: Treat via all existing plugged holes. (11 plugs each side)

Wheel arch rear/panel: Treatment via 1 drilled hole and existing

Wheel arch front: Remove/flip wheel arch liner. Treat longitudinal member via existing holes. See fig 5 for treatment of top

Wheel arch front top member: Treat via existing holes and gaps. Treat panel via existing plugged hole.

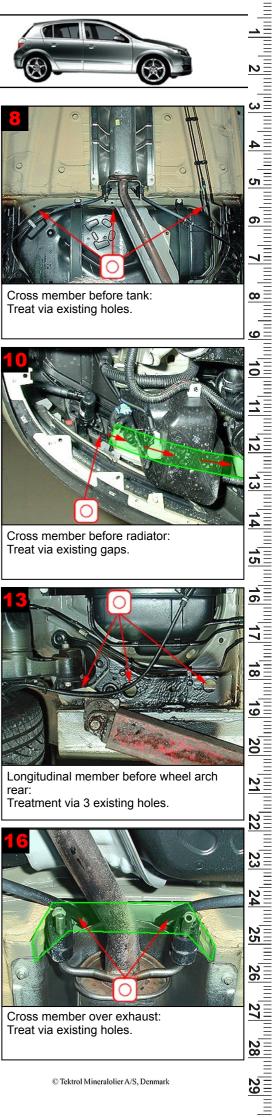
Cross member after tank: Treat via existing holes.

Cross member before tank: Treat via existing holes.
