Treatment diagram

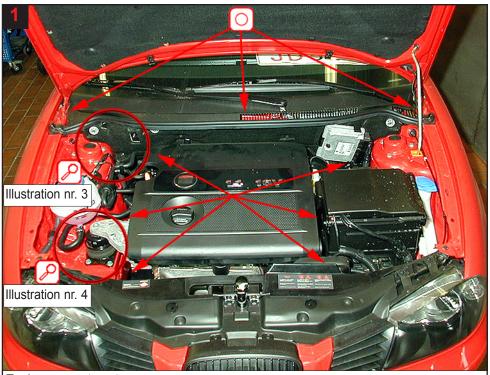
Engine compartment:

Cowl: Treat via existing holes and from sides. Treat on top of longitudinal member, behind spring struts and under battery box. See fig 3 and 4 for correct treatment.

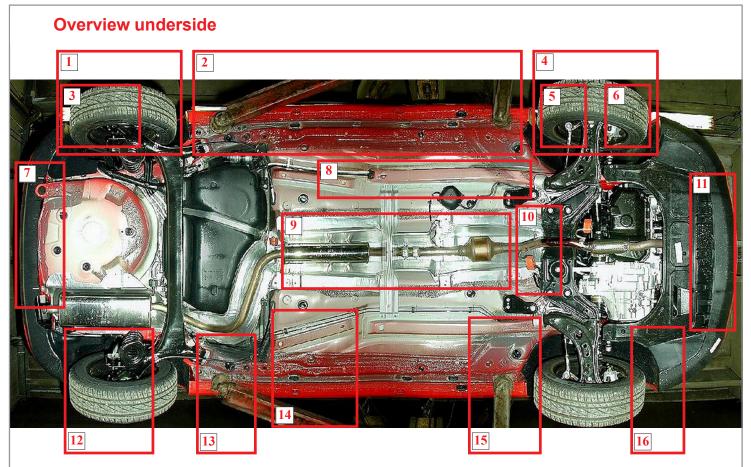
Underside

Wheel arch rear/rear wing: Remove wheel arch liner. Treat reinforcements for shock absorber via existing holes. See fig 3 for correct treatment of rear wing.
