Floor level

Seat Toledo

Model 2005

Underside

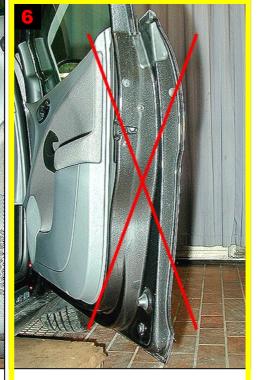
A-pillar: 3 drill holes for correct treatment.

Front door: No treatment pressure sensor for AIRBAG.
