Treatment diagram

Seat Toledo Model 2005

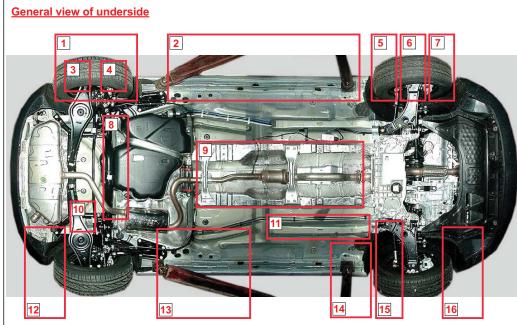
Underside

Wheel arch rear/panel: Treat via 2 drilled holes as well as via exist-ing plugged holes. All measurements to be observed. Wheel arch rear: Treatment via existing and plugged hole.

Wheel arch front/panel: Treat via 1 drilled hole and existing plugged

Wheel arch front and longitudinal member: Drill 1 hole for correct treatment. Reinforcements: See fig. 15.
