Seat Altea 4D - HB Model 2004

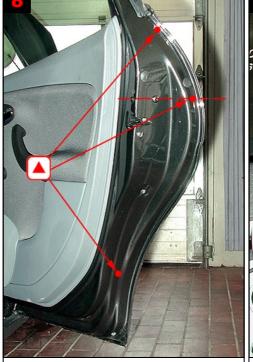
B-pillar: Drill 2 holes for correct treatment.

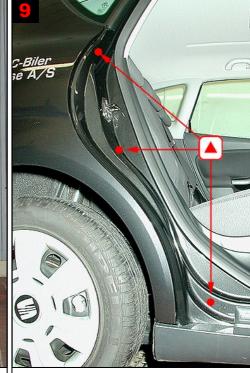
Rear door: Treat via 3 drilled holes. Centre drill hole level with screws for locking device.

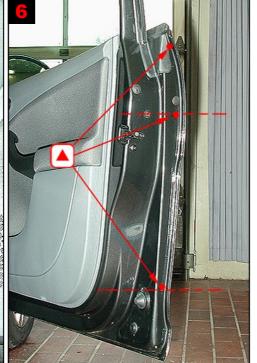
A-pillar: Drill 2 holes for correct treatment.
