Treatment diagram

Skoda Fabia **Model 2000**

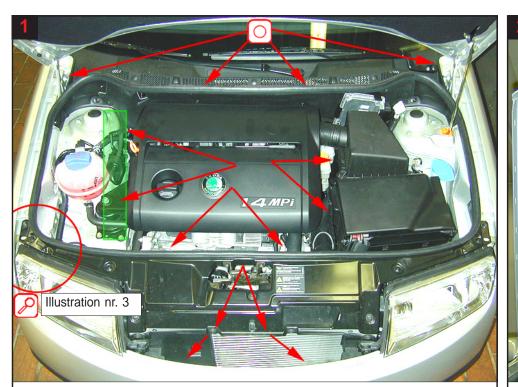
Bonnet lid.

flange.

Treat front via existing holes.

By windscreen. Remove 5 clips.

Side. Remove 1 clip centre and along plate

Floor level

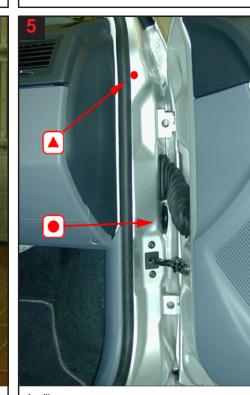
tion nr 4A

> Front door. Treat via 3 drilled holes. See fig 4A for drilling at correct level.

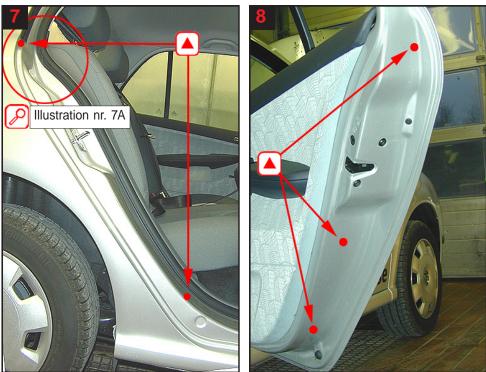
C-pillar. Treat via 2 drilled holes, top drilling is for part treatment of rear wing. See fig 7A for drilling at correct level.

C-pillar Drill 1 hole directly below rubber strip for part treatment of rear wing.

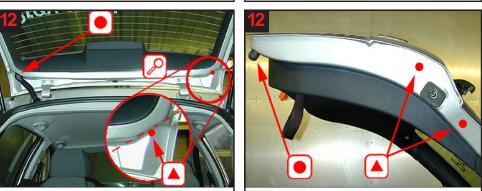
Rear panel and reinforcement. Drill 1 hole right and 1 hole left between rubber strip and tail light.

Tailgate at roof. 1 drilling and via grommet.
