# **Ssangyong Rexton 4WD Model 2005**

Treatment diagram

# Treatment diagram

### Underside

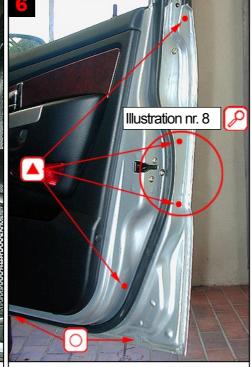
A-pillar: Drill 2 holes for correct treatment. Drill level right below door hinges.

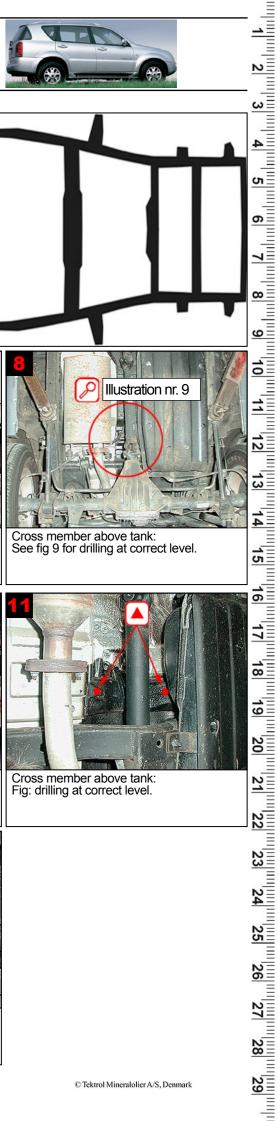
Cross member above tank: See fig. 11 for drilling at correct level.

Cross member above tank: Fig: drilling at correct level.
