Treatment diagram

## Suzuki Ignis

Suzuki Ignis

**Model 2001**

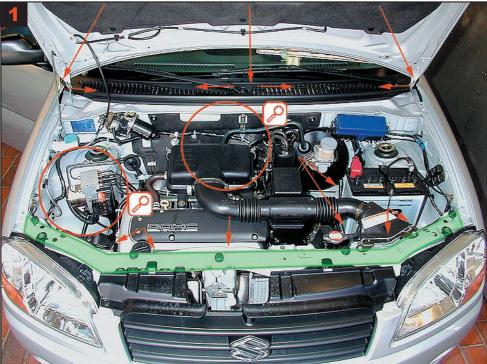
Floor level

Engine compartment:
Cowl: Treat from sides and gaps in grate. Treatment on top of longitudinal members, behind spring struts, under battery and fuse box and treatment of reinforcement for engine suspension. Cross member behind engine: Treatment of locking plate via existing holes and up under. See fig 3 and 4 for correct treatment.

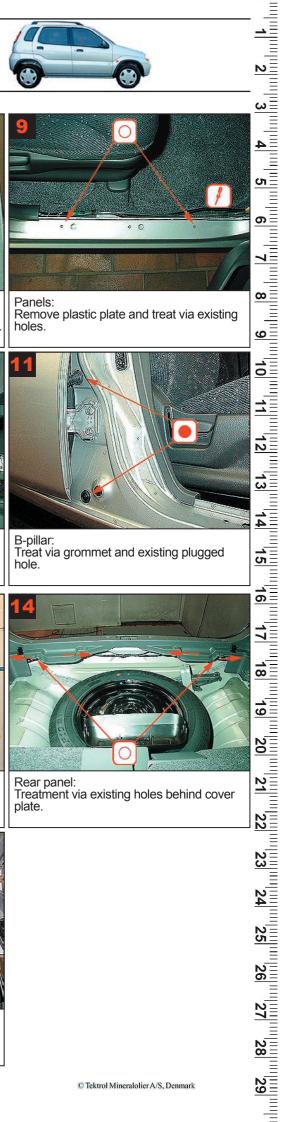
Remove plastic plate and treat via existing

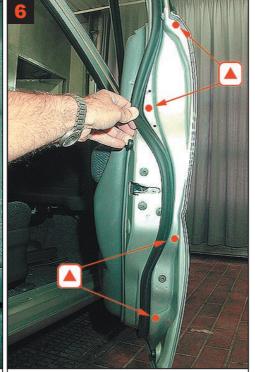
A-pillar and front wing: A-pillar: Treat via 2 drilled holes. Front wing: Treat with lance from clearing between Apillar and wing.
