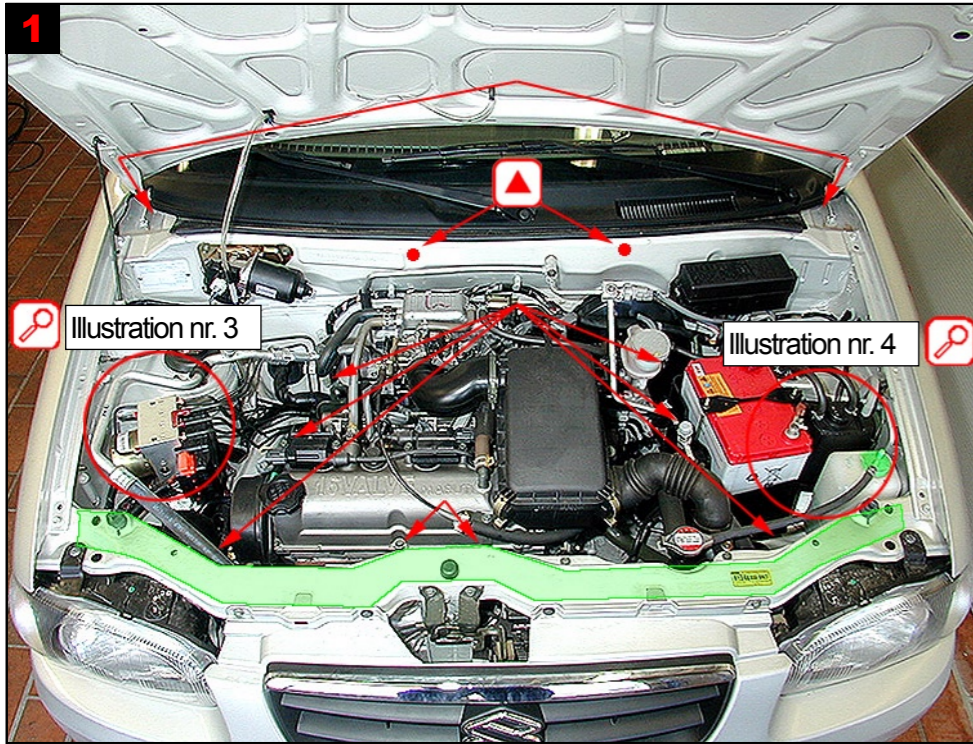
**1**  
Engine compartment:  
Cowl: Treat via 2 drilled holes. Caution when treating from sides.  
Treatment on top of longitudinal members, behind spring struts, under battery and fuse box and treatment of reinforcement for engine suspension. Treatment of locking plate via existing holes and up under. See fig 3 and 4 for correct treatment.
