Treatment diagram

VW Passat 4D - Sedan

Model 2005

Floor level

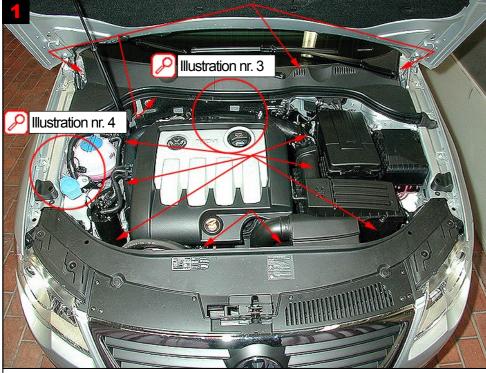
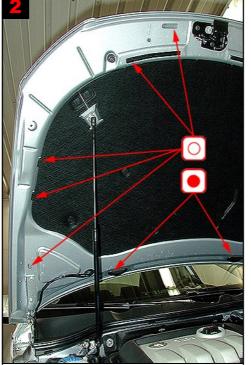
Engine compartment: Cowl: Flip plastic plate right side - treatment in under, left side treatment via existing holes. Treatment behind spring struts, on top of longitudinal members, under battery and air filter box and treatment of locking plate via existing holes.

Bonnet lid: Treat via existing holes. Treatment via exist-ing plugged holes for washer.

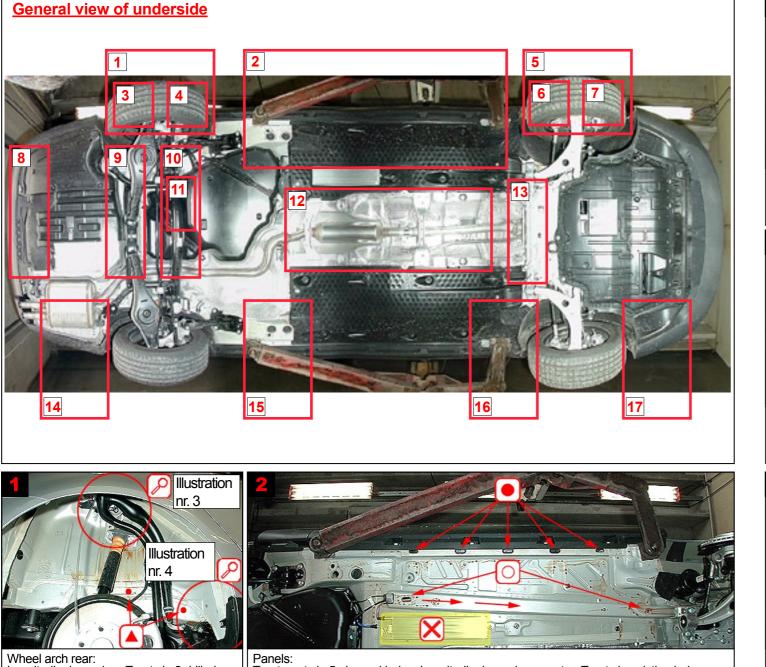
Underside

Treatment via 5 plugged holes. Longitudinal members centre: Treat via existing holes.

Wheel arch rear: Treat via existing and plugged holes.

Wheel arch rear/panel: Treatment via 2 plugged holes.

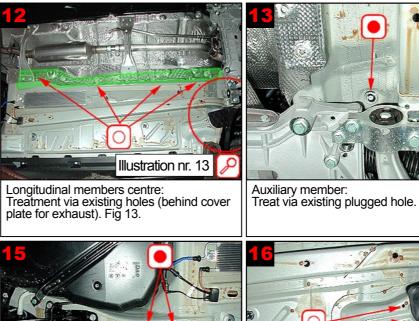
Small cross member after front wheel arch: Treat via existing holes. Longitudinal member before wheel arch rear: Treat via existing plugged holes.
