Floor level

Volvo V 50

Model 2004

Underside

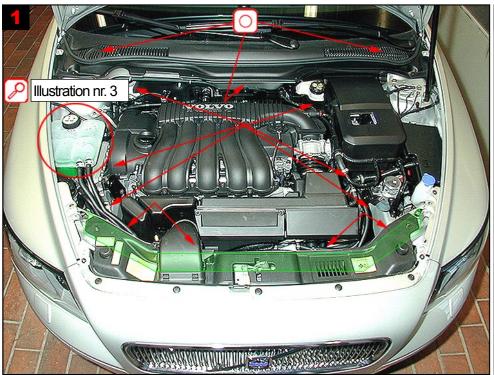
Engine compartment:
Cowl: Treatment from sides and flip plastic plate.
Treatment on top of longitudinal members, behind spring struts, under battery and fusebox. Treatment of locking plate via existing holes and up under. See fig 3 for correct treatment.

Bonnet lid (plastmaterial): Treatment of reinforcement via existing holes.

Front door sectional view: Drill level with door lock.

Rear door sectional view: Treat via 1 drill hole just below lock mounting.

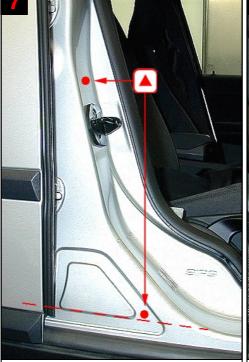
B-pillar: Treat via 2 drilled holes.

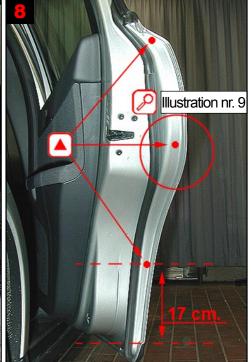
Rear door: Treat via 3 drilled holes. See fig 9 for drilling at correct level.

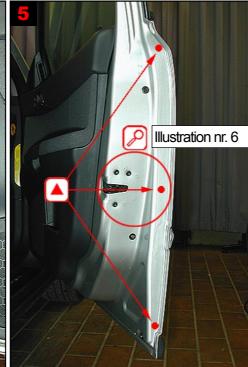
Front door: Treat via 3 drilled holes. See fig 6 for drilling at correct level.

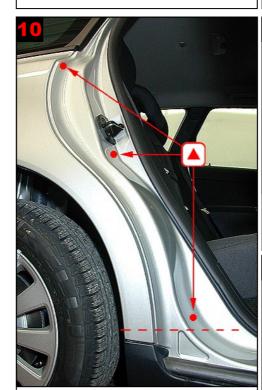
C-pillar: Treat via 3 drilled holes. Lower drill hole: Drill level with upper edge of plate flange

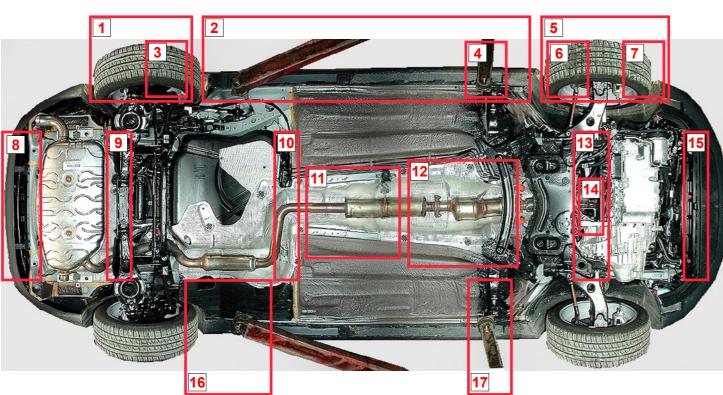
Wheel arch rear: Drill 2 holes in longitudinal member and use existing hole for correct treatment. See fig 3 for correct treatment.

Wheel arch rear/panel: Treat via 1 drilled hole level with clips in wheel arch liner. Treat with lance.

Treat via 3 drilled holes per side. See fig. 4 for correct drilling level.

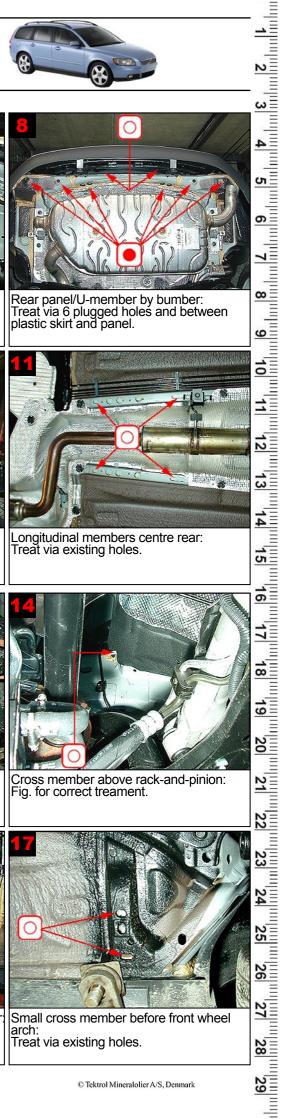
Longitudinal member after wheel arch rear: Treat via existing holes.

Small cross member before front wheel arch: Treat via existing holes.
