Floor level

Underside

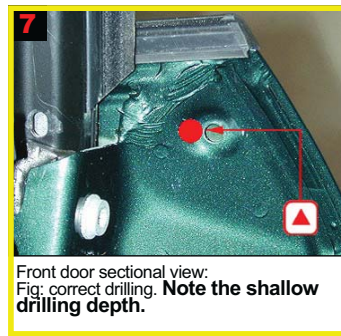
7 Front door sectional view:  
Fig: correct drilling. **Note the shallow drilling depth.**

6 Front door:  
Treatment via 4 drilled holes. 2nd. drilling level just above childproof locking device. 3rd drill hole level with side trim. See fig. 7 for correct top drilling. See fig. 10 for drilling at correct level.
