DAEWOO NUBIRA 1997-

VEHICLE ON THE FLOOR

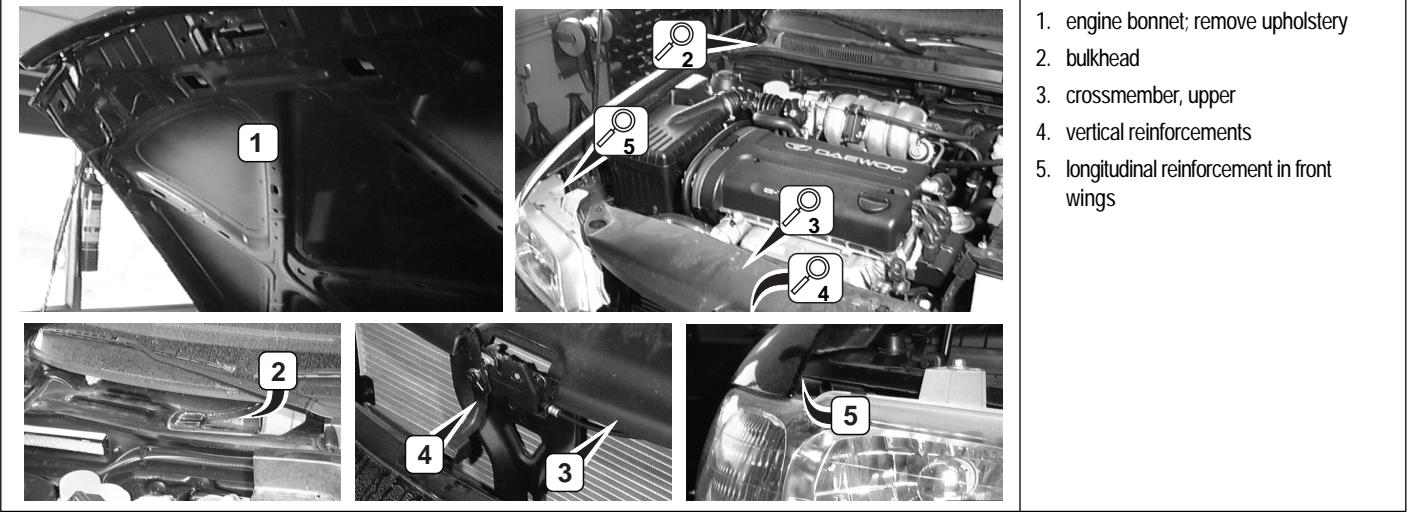
1. engine bonnet; remove upholstery
2. bulkhead
3. crossmember, upper
4. vertical reinforcements
5. longitudinal reinforcement in front wings

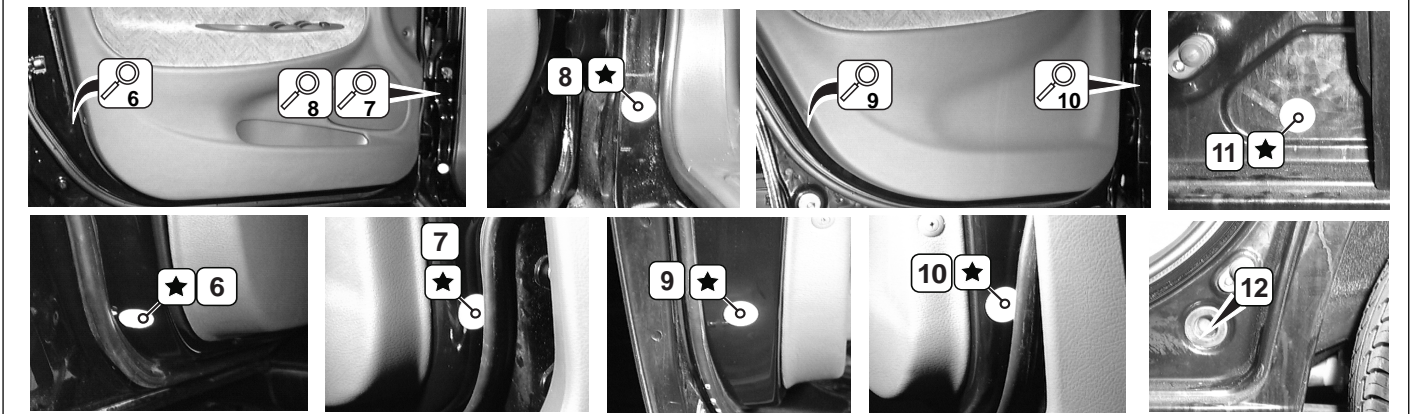
6. front doors; rear section; drill and plug hole
7. front doors; front section; drill and plug hole
8. 'A' posts; drill and plug hole
9. rear doors; rear section; drill and plug hole

10. rear doors; front section; drill and plug hole
11. 'B' posts; drill and plug hole; pull out and lock safety belt
12. 'C' posts; remove rubber sealing

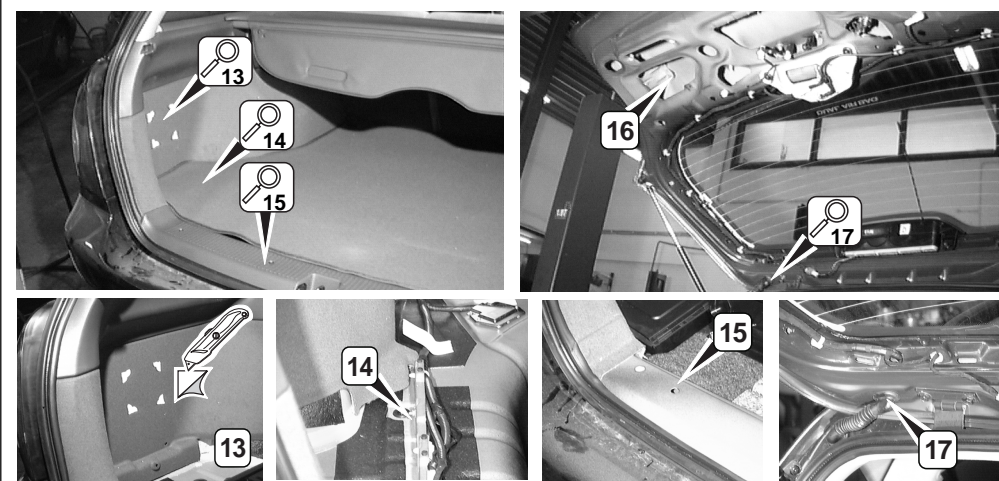
13. 'C' posts; 'D' posts; wheel arches
14. longitudinal members; remove upholstery
15. crossmember, upper; remove upholstery
16. tailgate; rear section; remove upholstery
17. tailgate; front section; remove rubber sealing

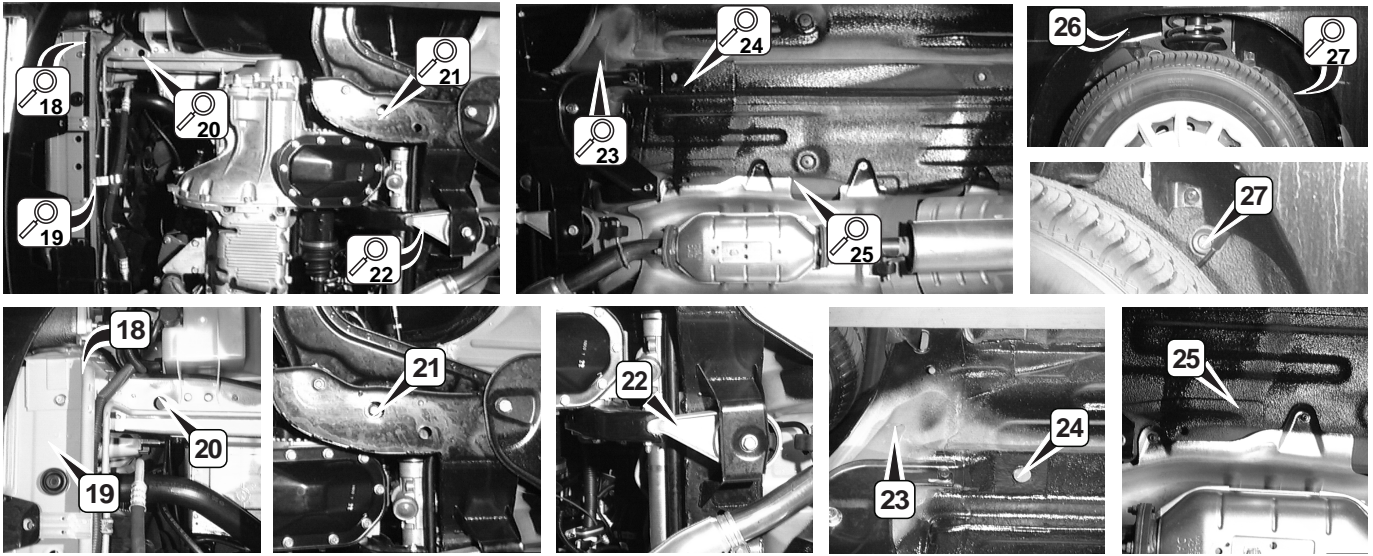
18. bumper brackets; towing eye mounting
 19. crossmember, lower
 20. front longitudinal members; front section
 21. subframe; suspension arms

22. engine mounting
 23. reinforcements at front end of floor panel
 24. floor panel; reinforcements; front section

25. tunnel reinforcement
 26. front wings; remove plastic insert
 27. longitudinal members; rear section; remove rubber sealing

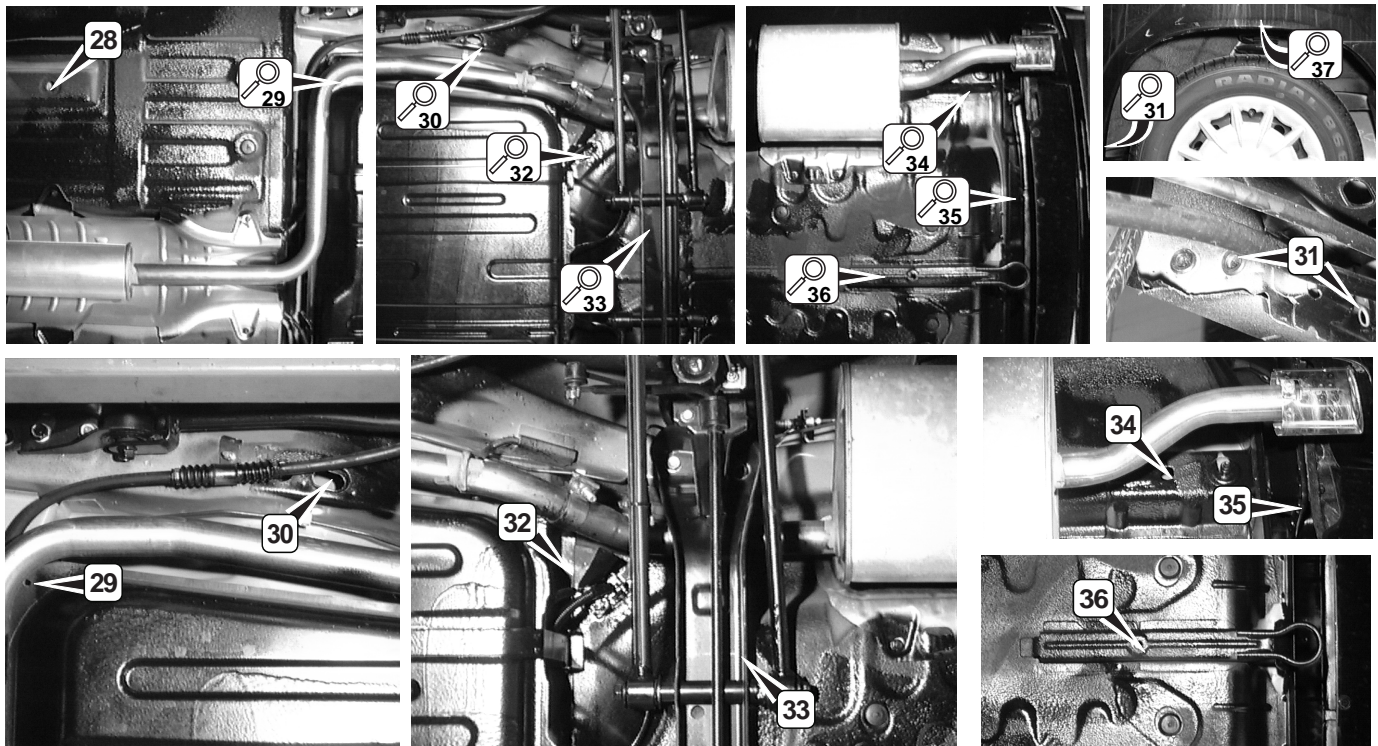
28. floor panel; reinforcements; rear section
 29. crossmember front of fuel tank
 30. rear longitudinal members; front section
 31. sills; rear section; remove rubber sealing

32. crossmember rear of fuel tank
 33. rear suspension
 34. rear longitudinal members; rear section
 35. crossmember, lower

36. towing eye mounting
 37. rear wings; remove plastic insert
