DAEWOO NUBIRA 1997-

VEHICLE ON THE FLOOR

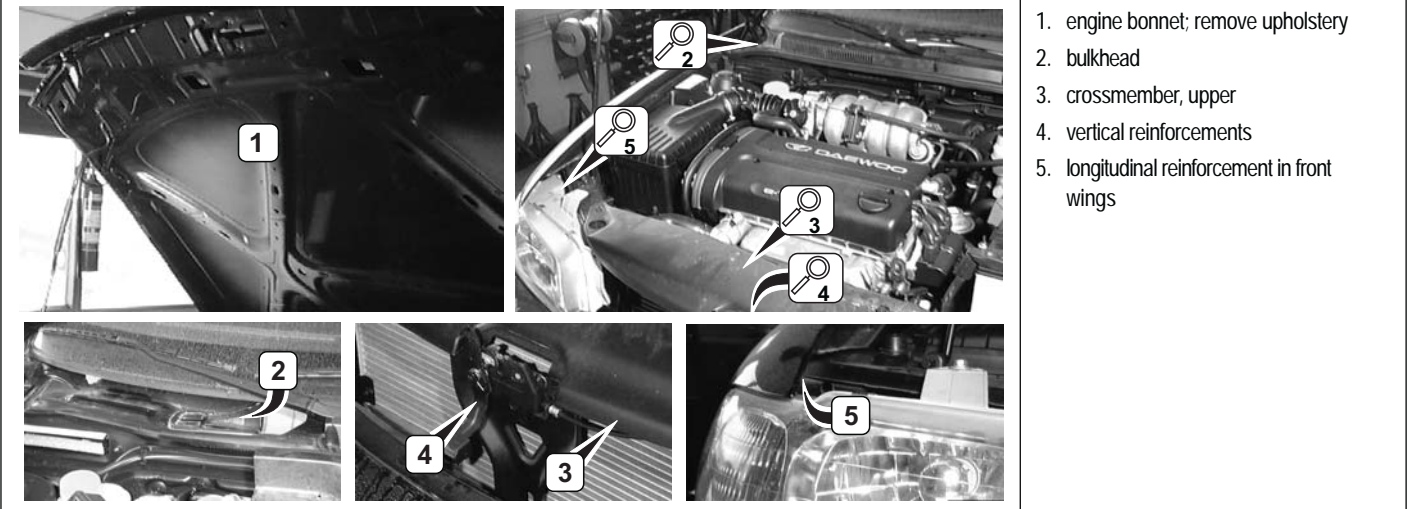
1. engine bonnet; remove upholstery
2. bulkhead
3. crossmember, upper
4. vertical reinforcements
5. longitudinal reinforcement in front wings

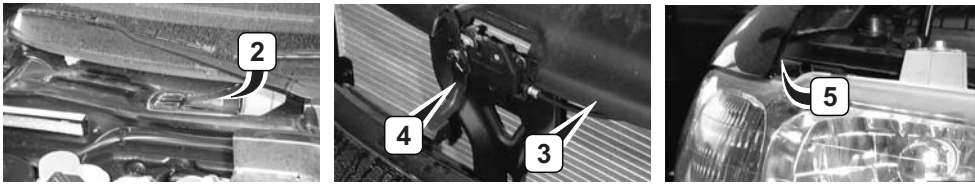
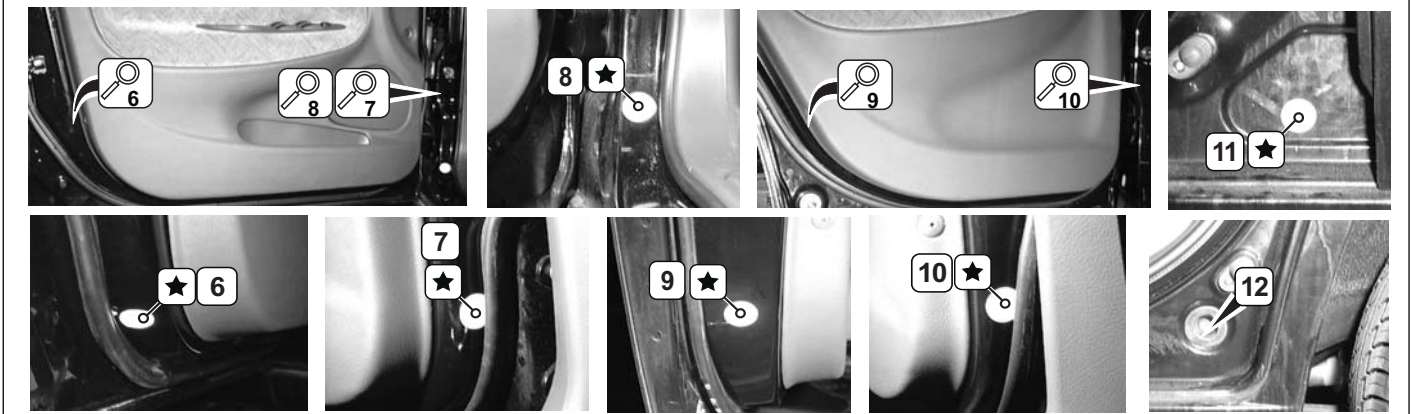
6. front doors; rear section; drill and plug hole
7. front doors; front section; drill and plug hole
8. 'A' posts; drill and plug hole
9. rear doors; rear section; drill and plug hole

10. rear doors; front section; drill and plug hole
11. 'B' posts; drill and plug hole; pull out and lock safety belt
12. 'C' posts; remove rubber sealing

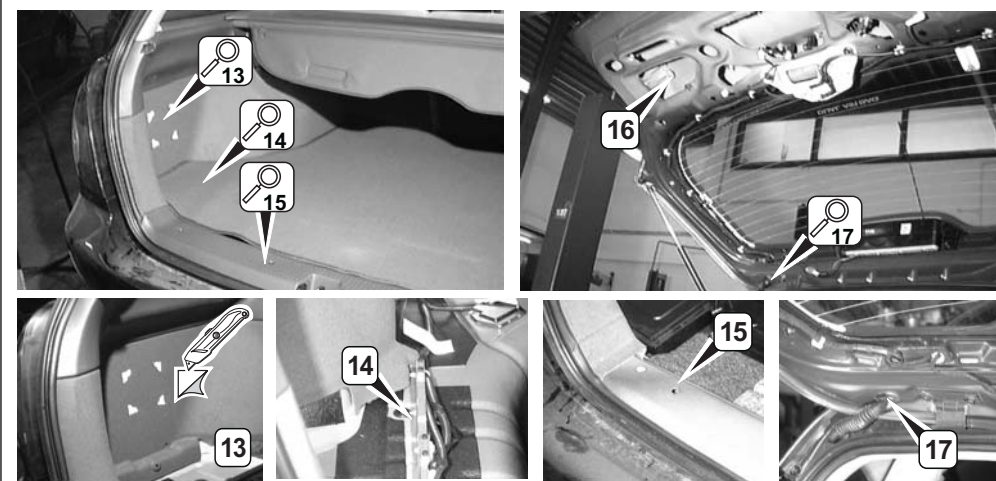
13. 'C' posts; 'D' posts; wheel arches
14. longitudinal members; remove upholstery
15. crossmember, upper; remove upholstery
16. tailgate; rear section; remove upholstery
17. tailgate; front section; remove rubber sealing

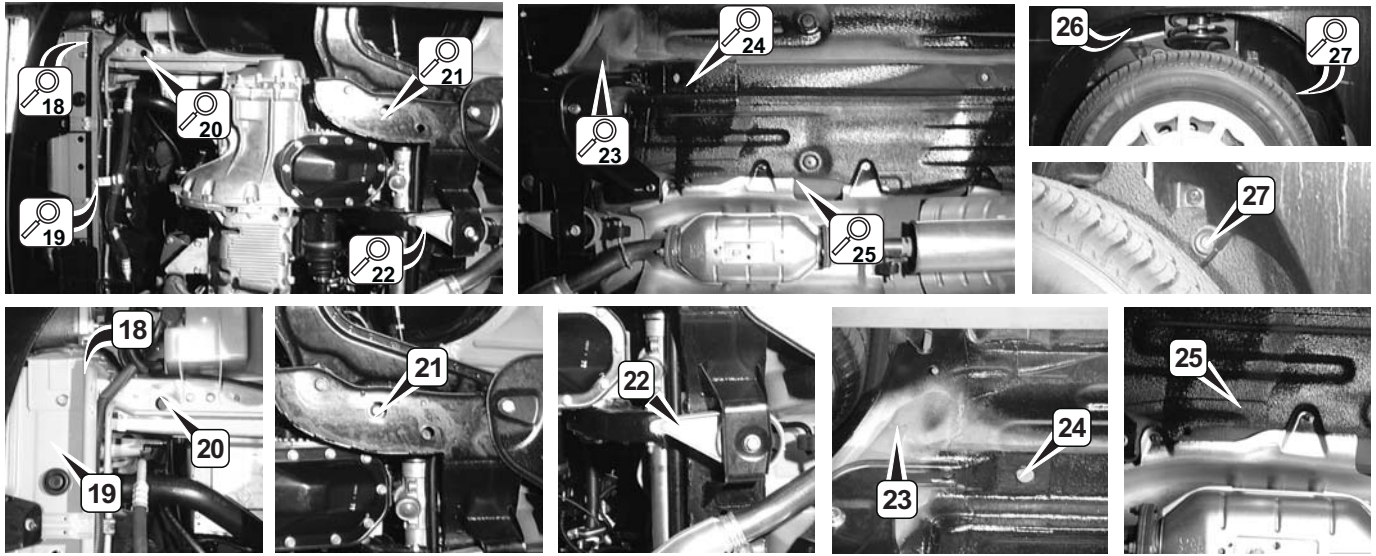
UNDERSIDE

18. bumper brackets; towing eye mounting
 19. crossmember, lower
 20. front longitudinal members; front section
 21. subframe; suspension arms

22. engine mounting
 23. reinforcements at front end of floor panel
 24. floor panel; reinforcements; front section

25. tunnel reinforcement
 26. front wings; remove plastic insert
 27. longitudinal members; rear section; remove rubber sealing

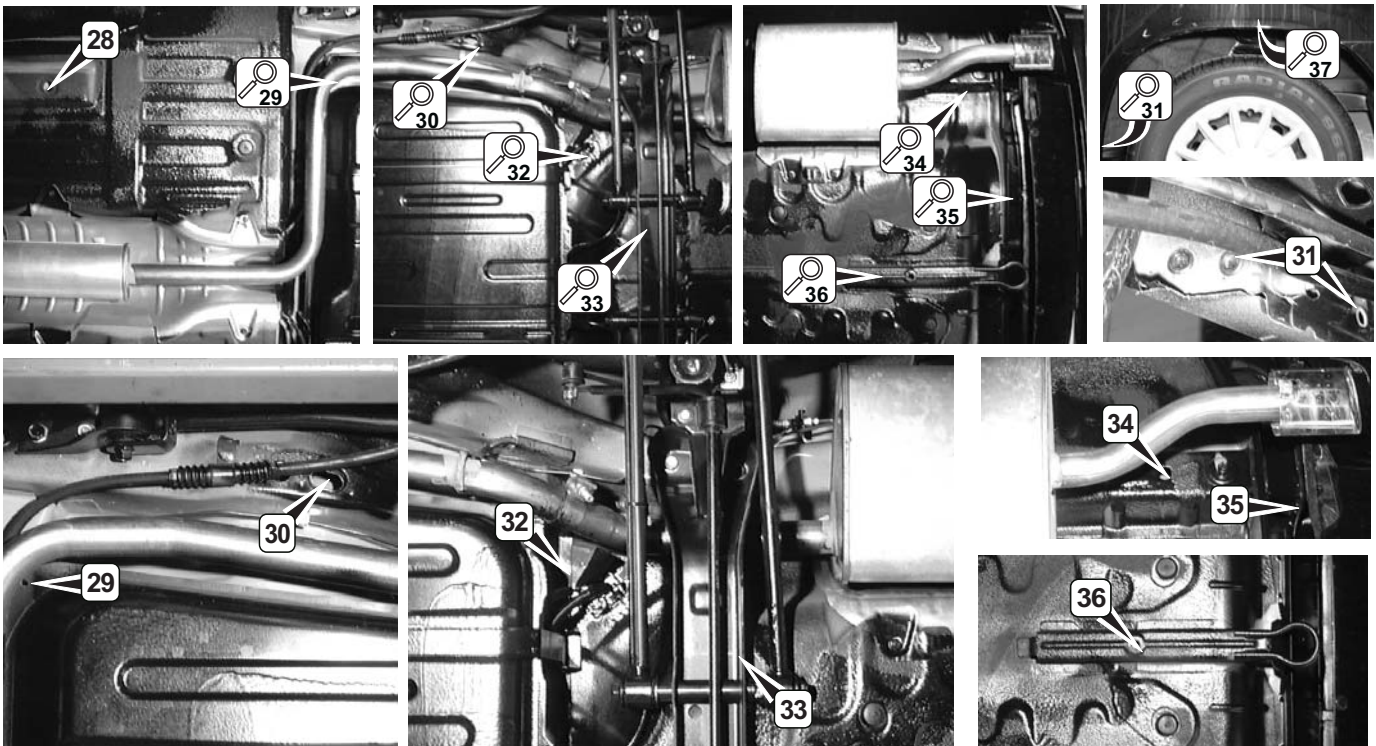
28. floor panel; reinforcements; rear section
 29. crossmember front of fuel tank
 30. rear longitudinal members; front section
 31. sills; rear section; remove rubber sealing

32. crossmember rear of fuel tank
 33. rear suspension
 34. rear longitudinal members; rear section
 35. crossmember, lower

36. towing eye mounting
 37. rear wings; remove plastic insert
