Treatment diagram

Ford Focus Stationcar

Model 2005

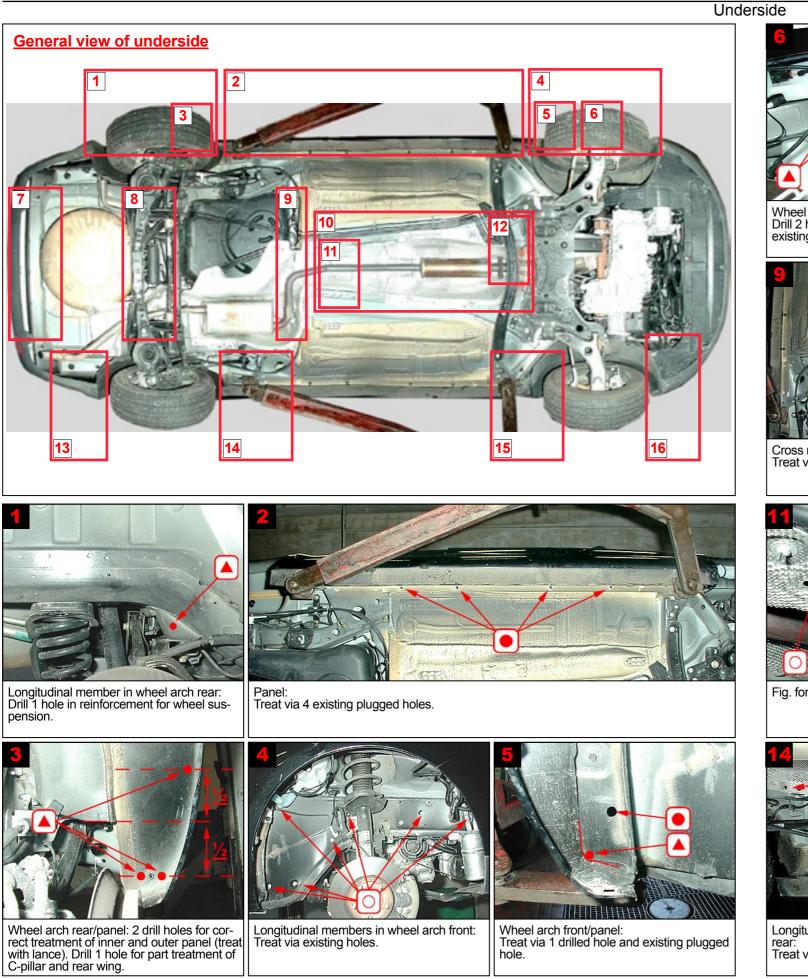
Longitudinal members centre and auxiliary members: Treat via existing holes and gaps. See fig 11 and 12.
