HYUNDAI ATOS 1998-

VEHICLE ON THE FLOOR

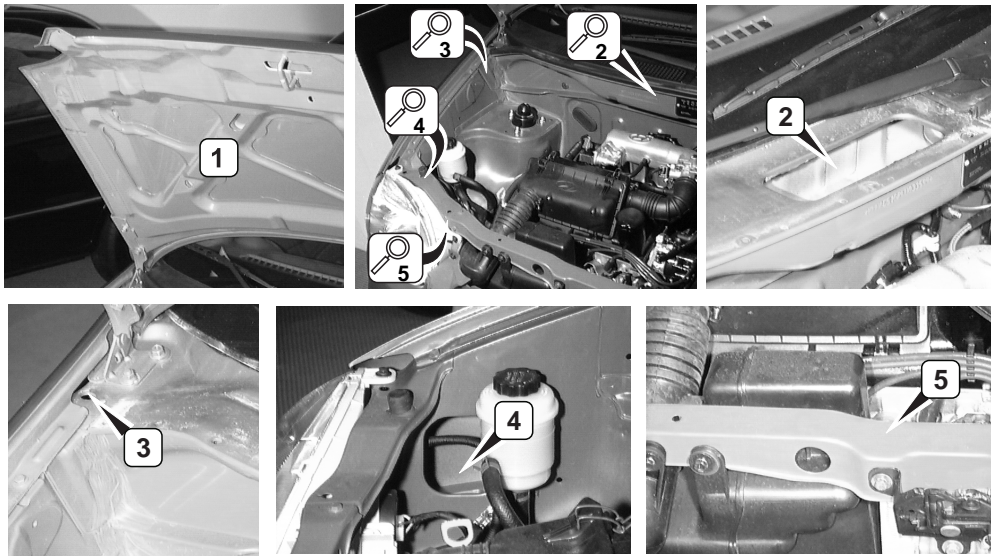
1. engine bonnet
2. bulkhead; detach panel; spray sparingly
3. front wings; rear section
4. front wings; front section
5. crossmember, upper

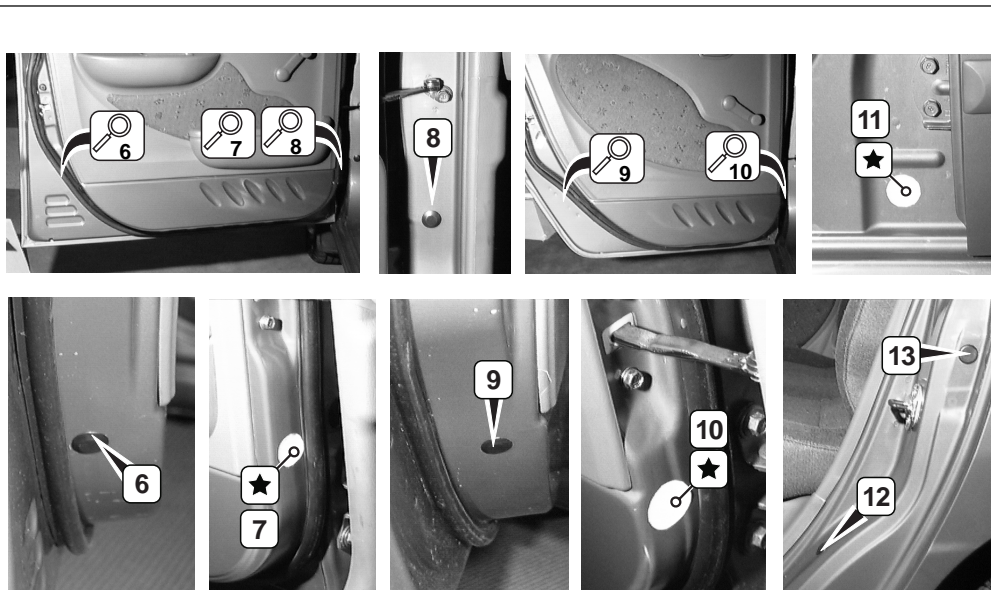
6. front doors; rear section; remove rubber sealing
7. front doors; front section; drill and plug hole
8. 'A' posts; remove rubber sealing
9. rear doors; rear section; remove rubber sealing
10. rear doors; front section; drill and plug hole
11. 'B' posts; drill and plug hole; pull out and lock safety belt
12. 'C' posts; bottom section
13. 'C' posts; top section; pull out and lock safety belt

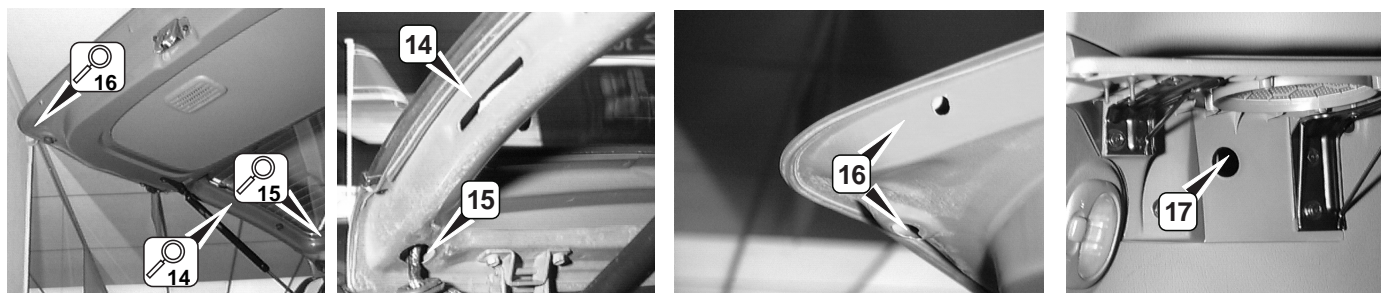
14. tailgate; left; right; remove upholstery
15. tailgate; front section; remove grommet

16. tailgate; rear section; through drain hole
17. 'C' posts; wheel arches; remove rubber sealing

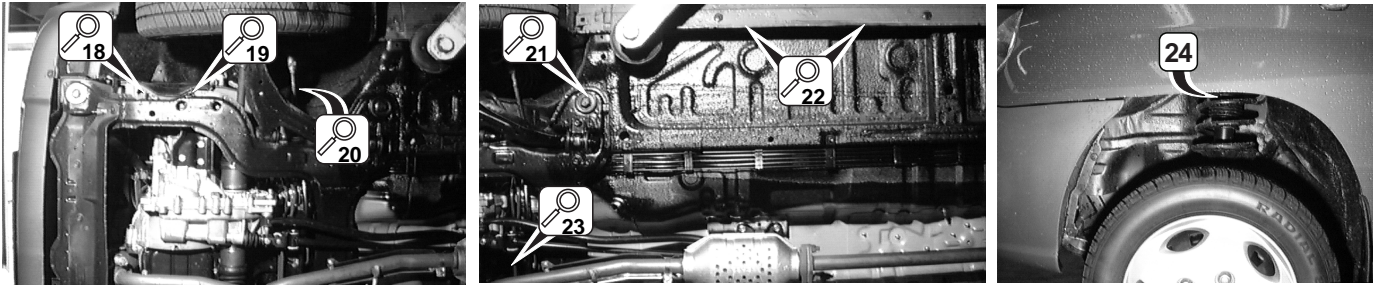
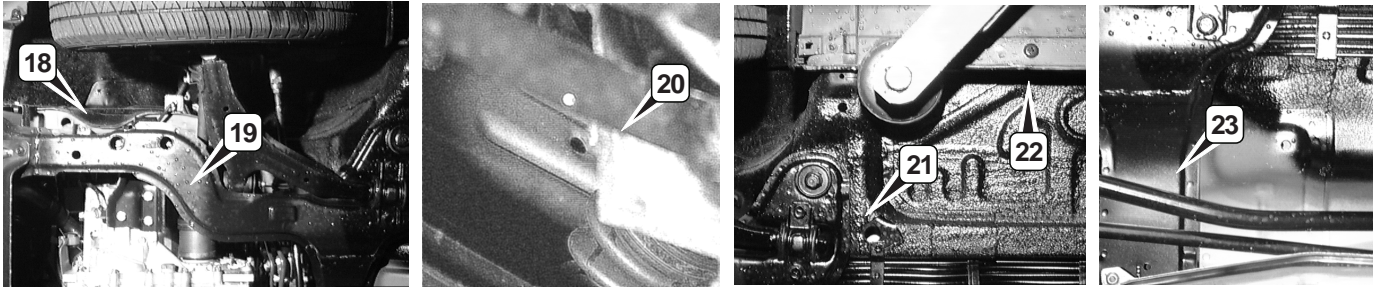
UNDERSIDE

18. front longitudinal members; front section
 19. subframe; front wheel suspension arms
 20. front longitudinal members; rear section

21. floor panel; reinforcements
 22. sills; front; remove rubber sealing

23. tunnel reinforcement
 24. front wings

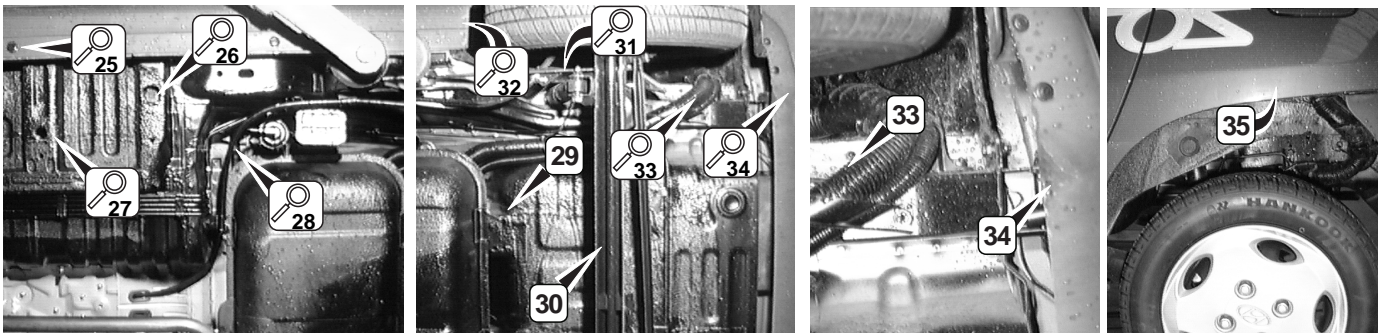
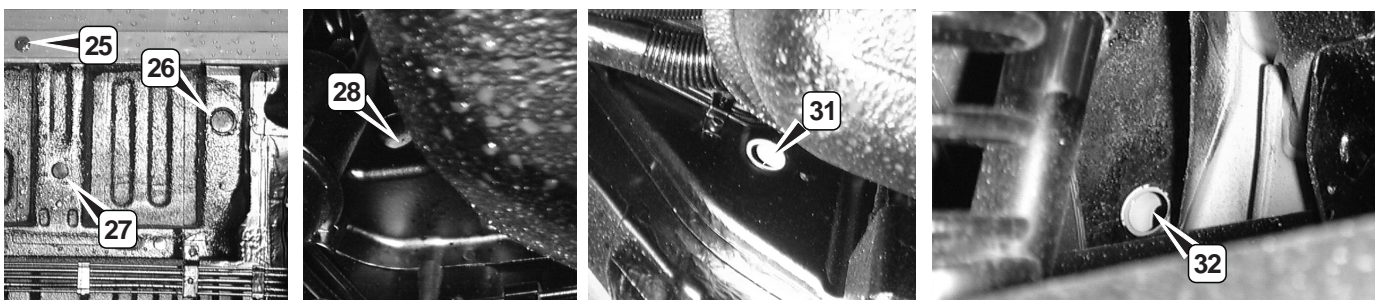
25. sills; rear; remove rubber sealing
 26. transversal reinforcement
 27. floor panel; reinforcements
 28. crossmember front of fuel tank

29. rear fuel tank mountings
 30. rear suspension
 31. rear longitudinal members; front section
 32. sills; rear section; remove rubber sealing

33. rear longitudinal members; rear section
 34. bumper brackets
 35. rear wings
