Floor level

Underside

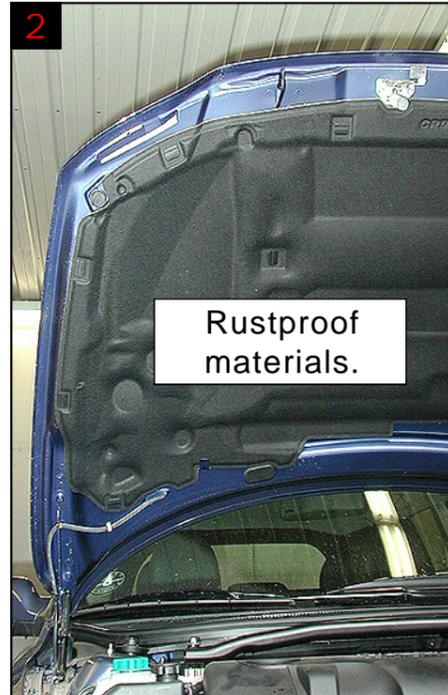
1
Engine compartment:
Cowl: Treatment via 2 drill holes in plastic grille. Treatment behind spring struts, on top of longitudinal members, under fluid reservoir, electronic box, fuse box and air filter box. Treatment of locking plate and top member in wing. See fig. 3 and 4.
